UNIDADE DE ACOLHIMENTO

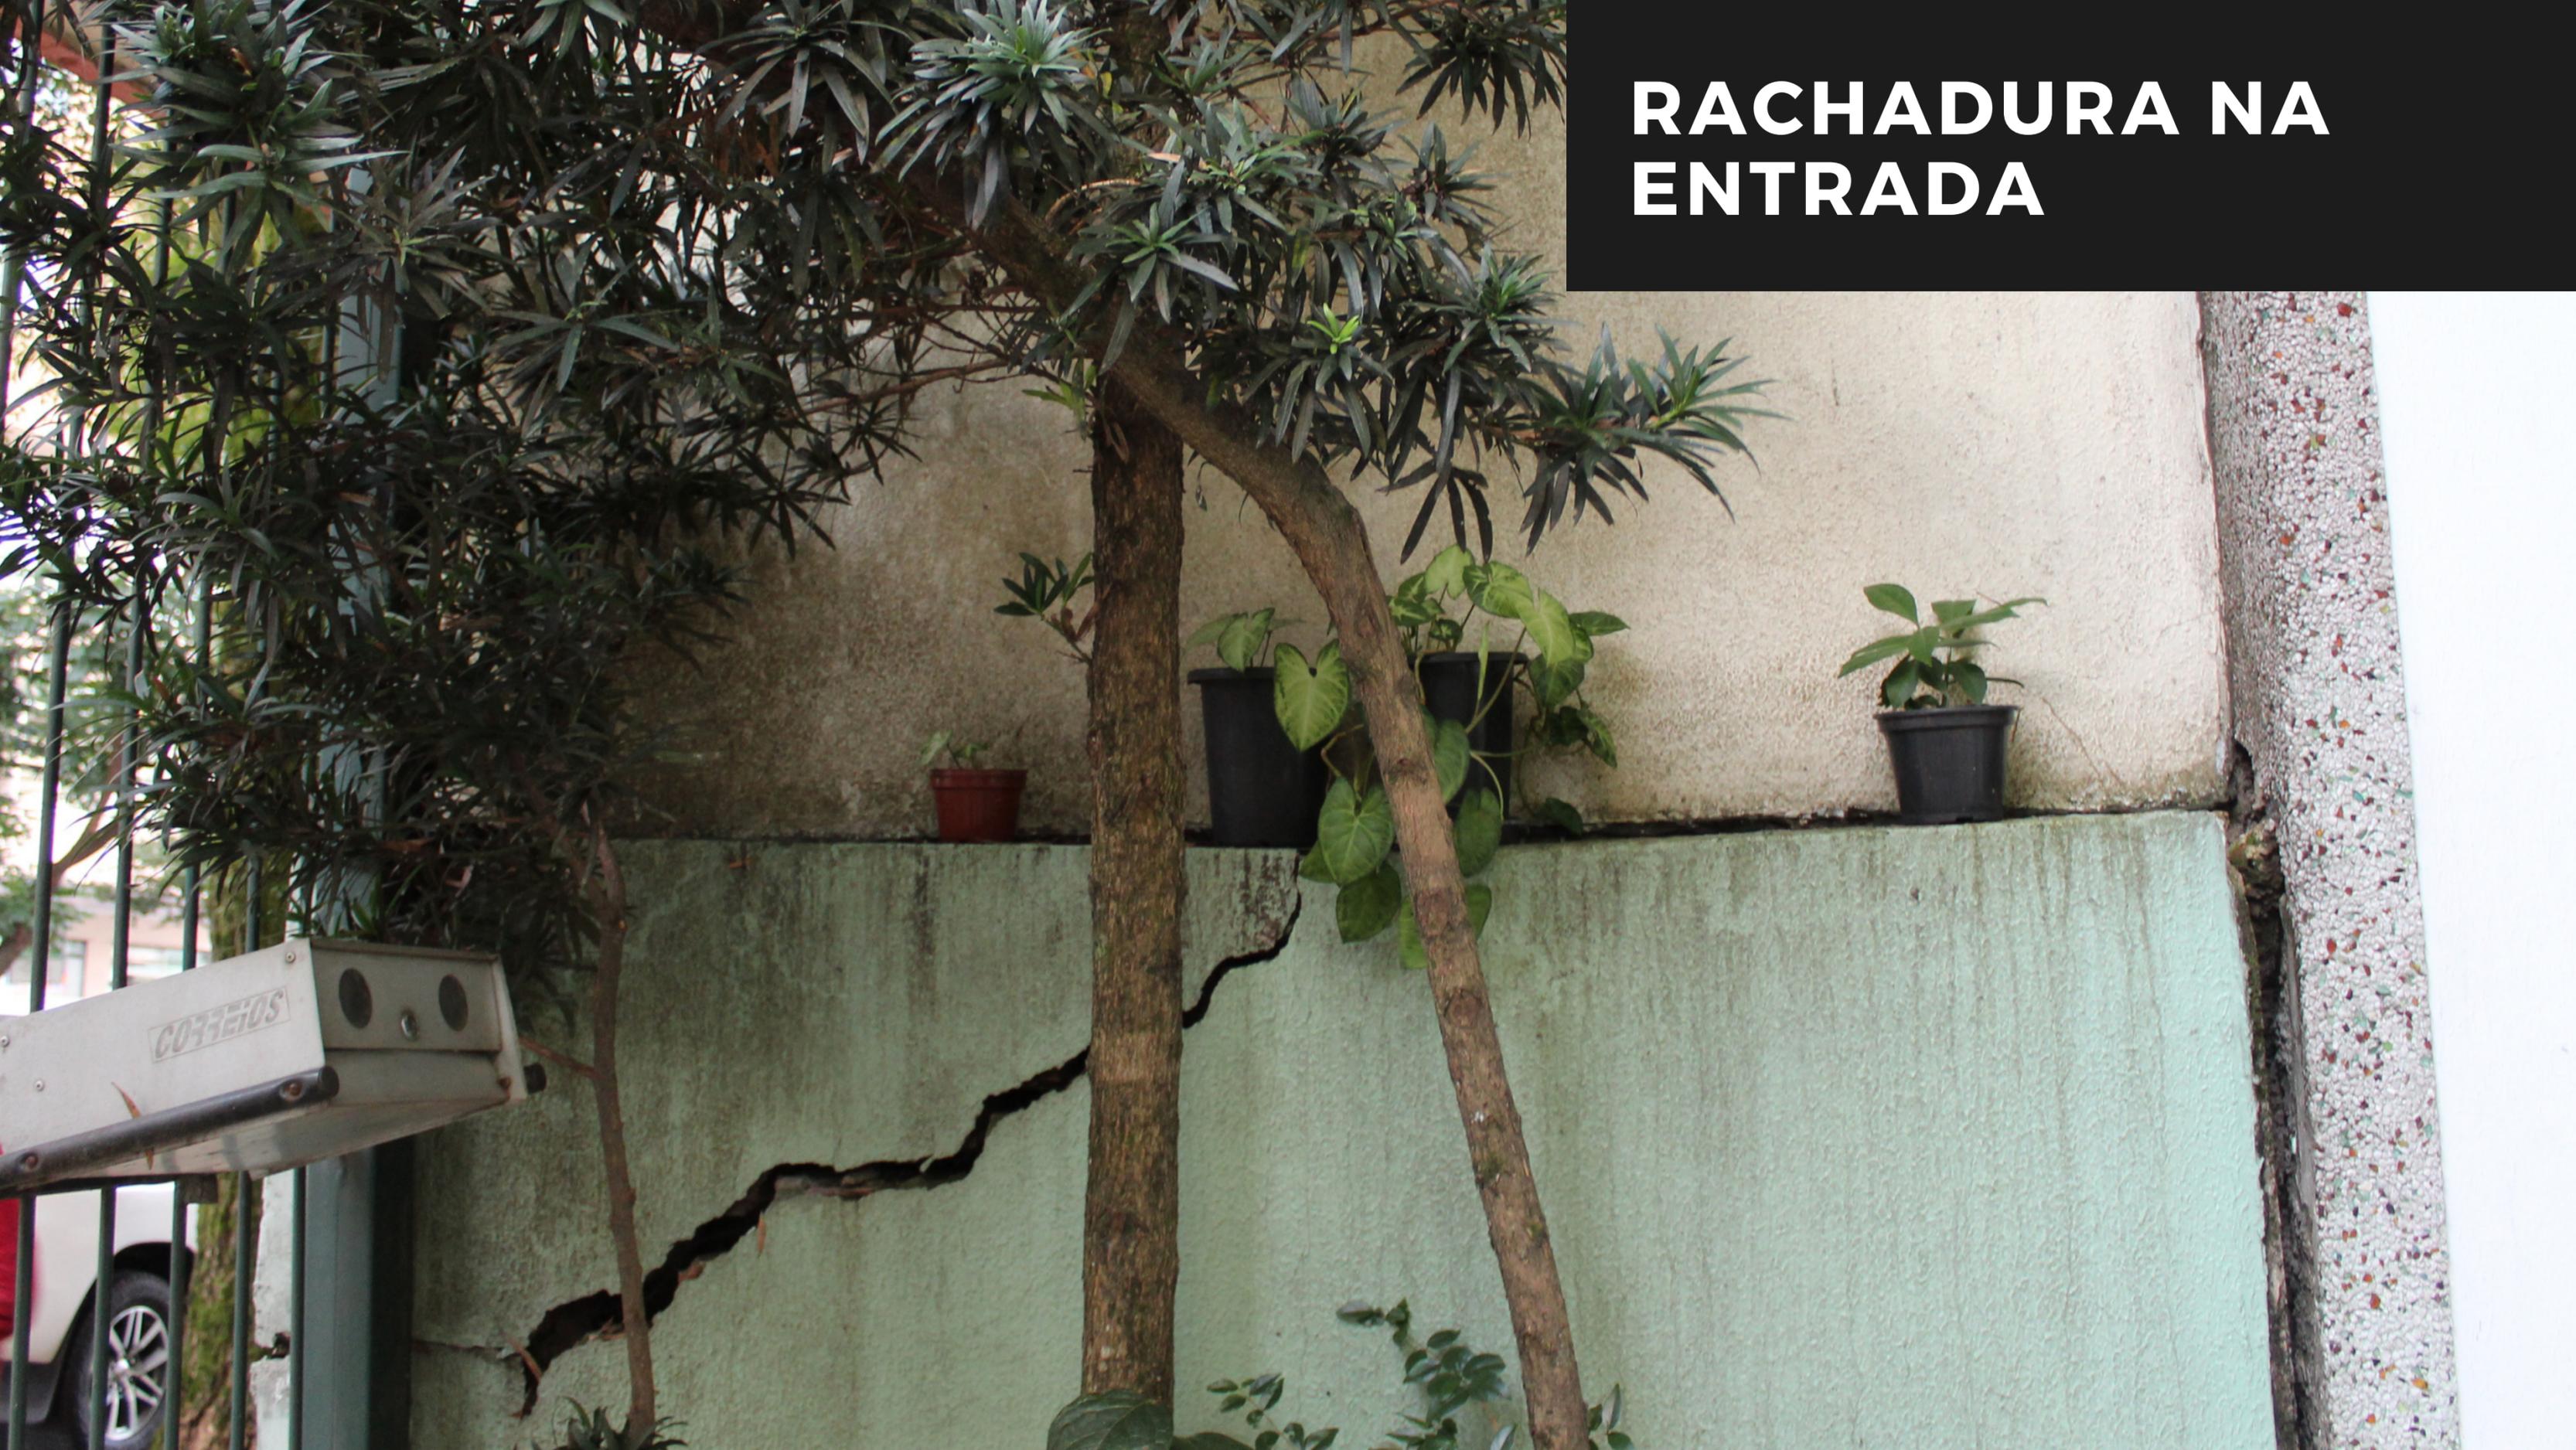
RACHADURA NA ENTRADA

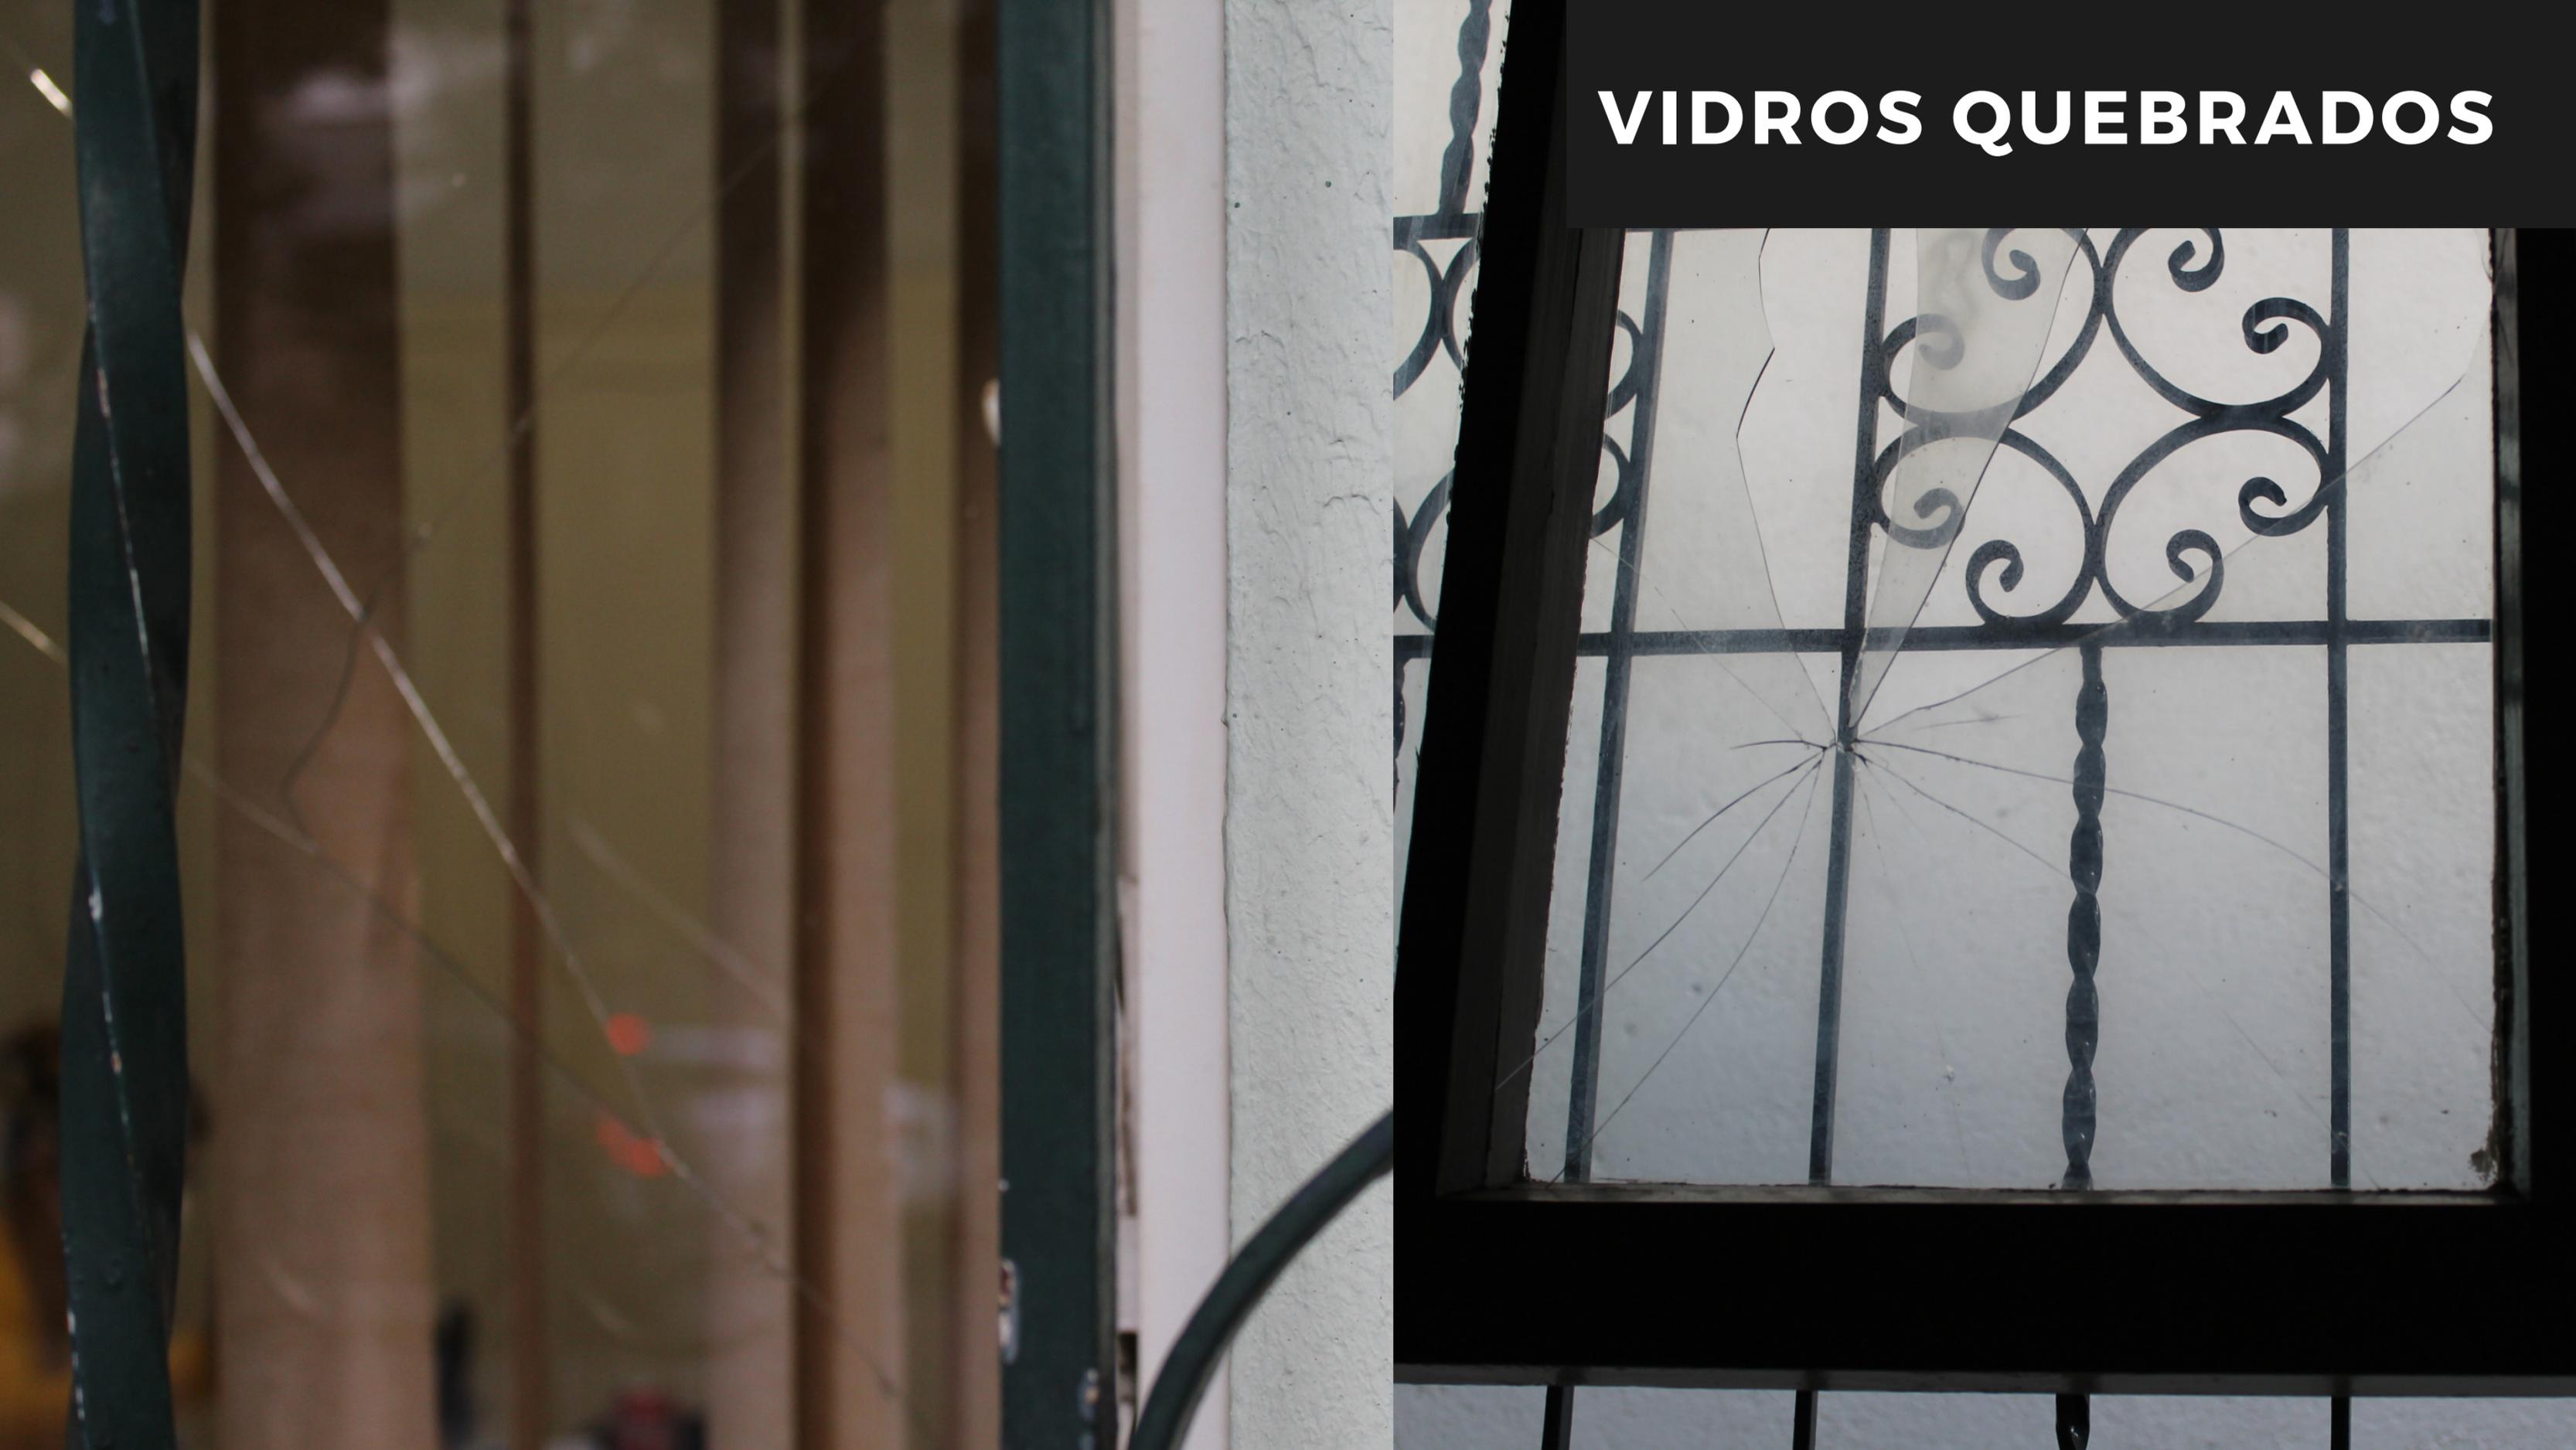
VIDROS QUEBRADOS

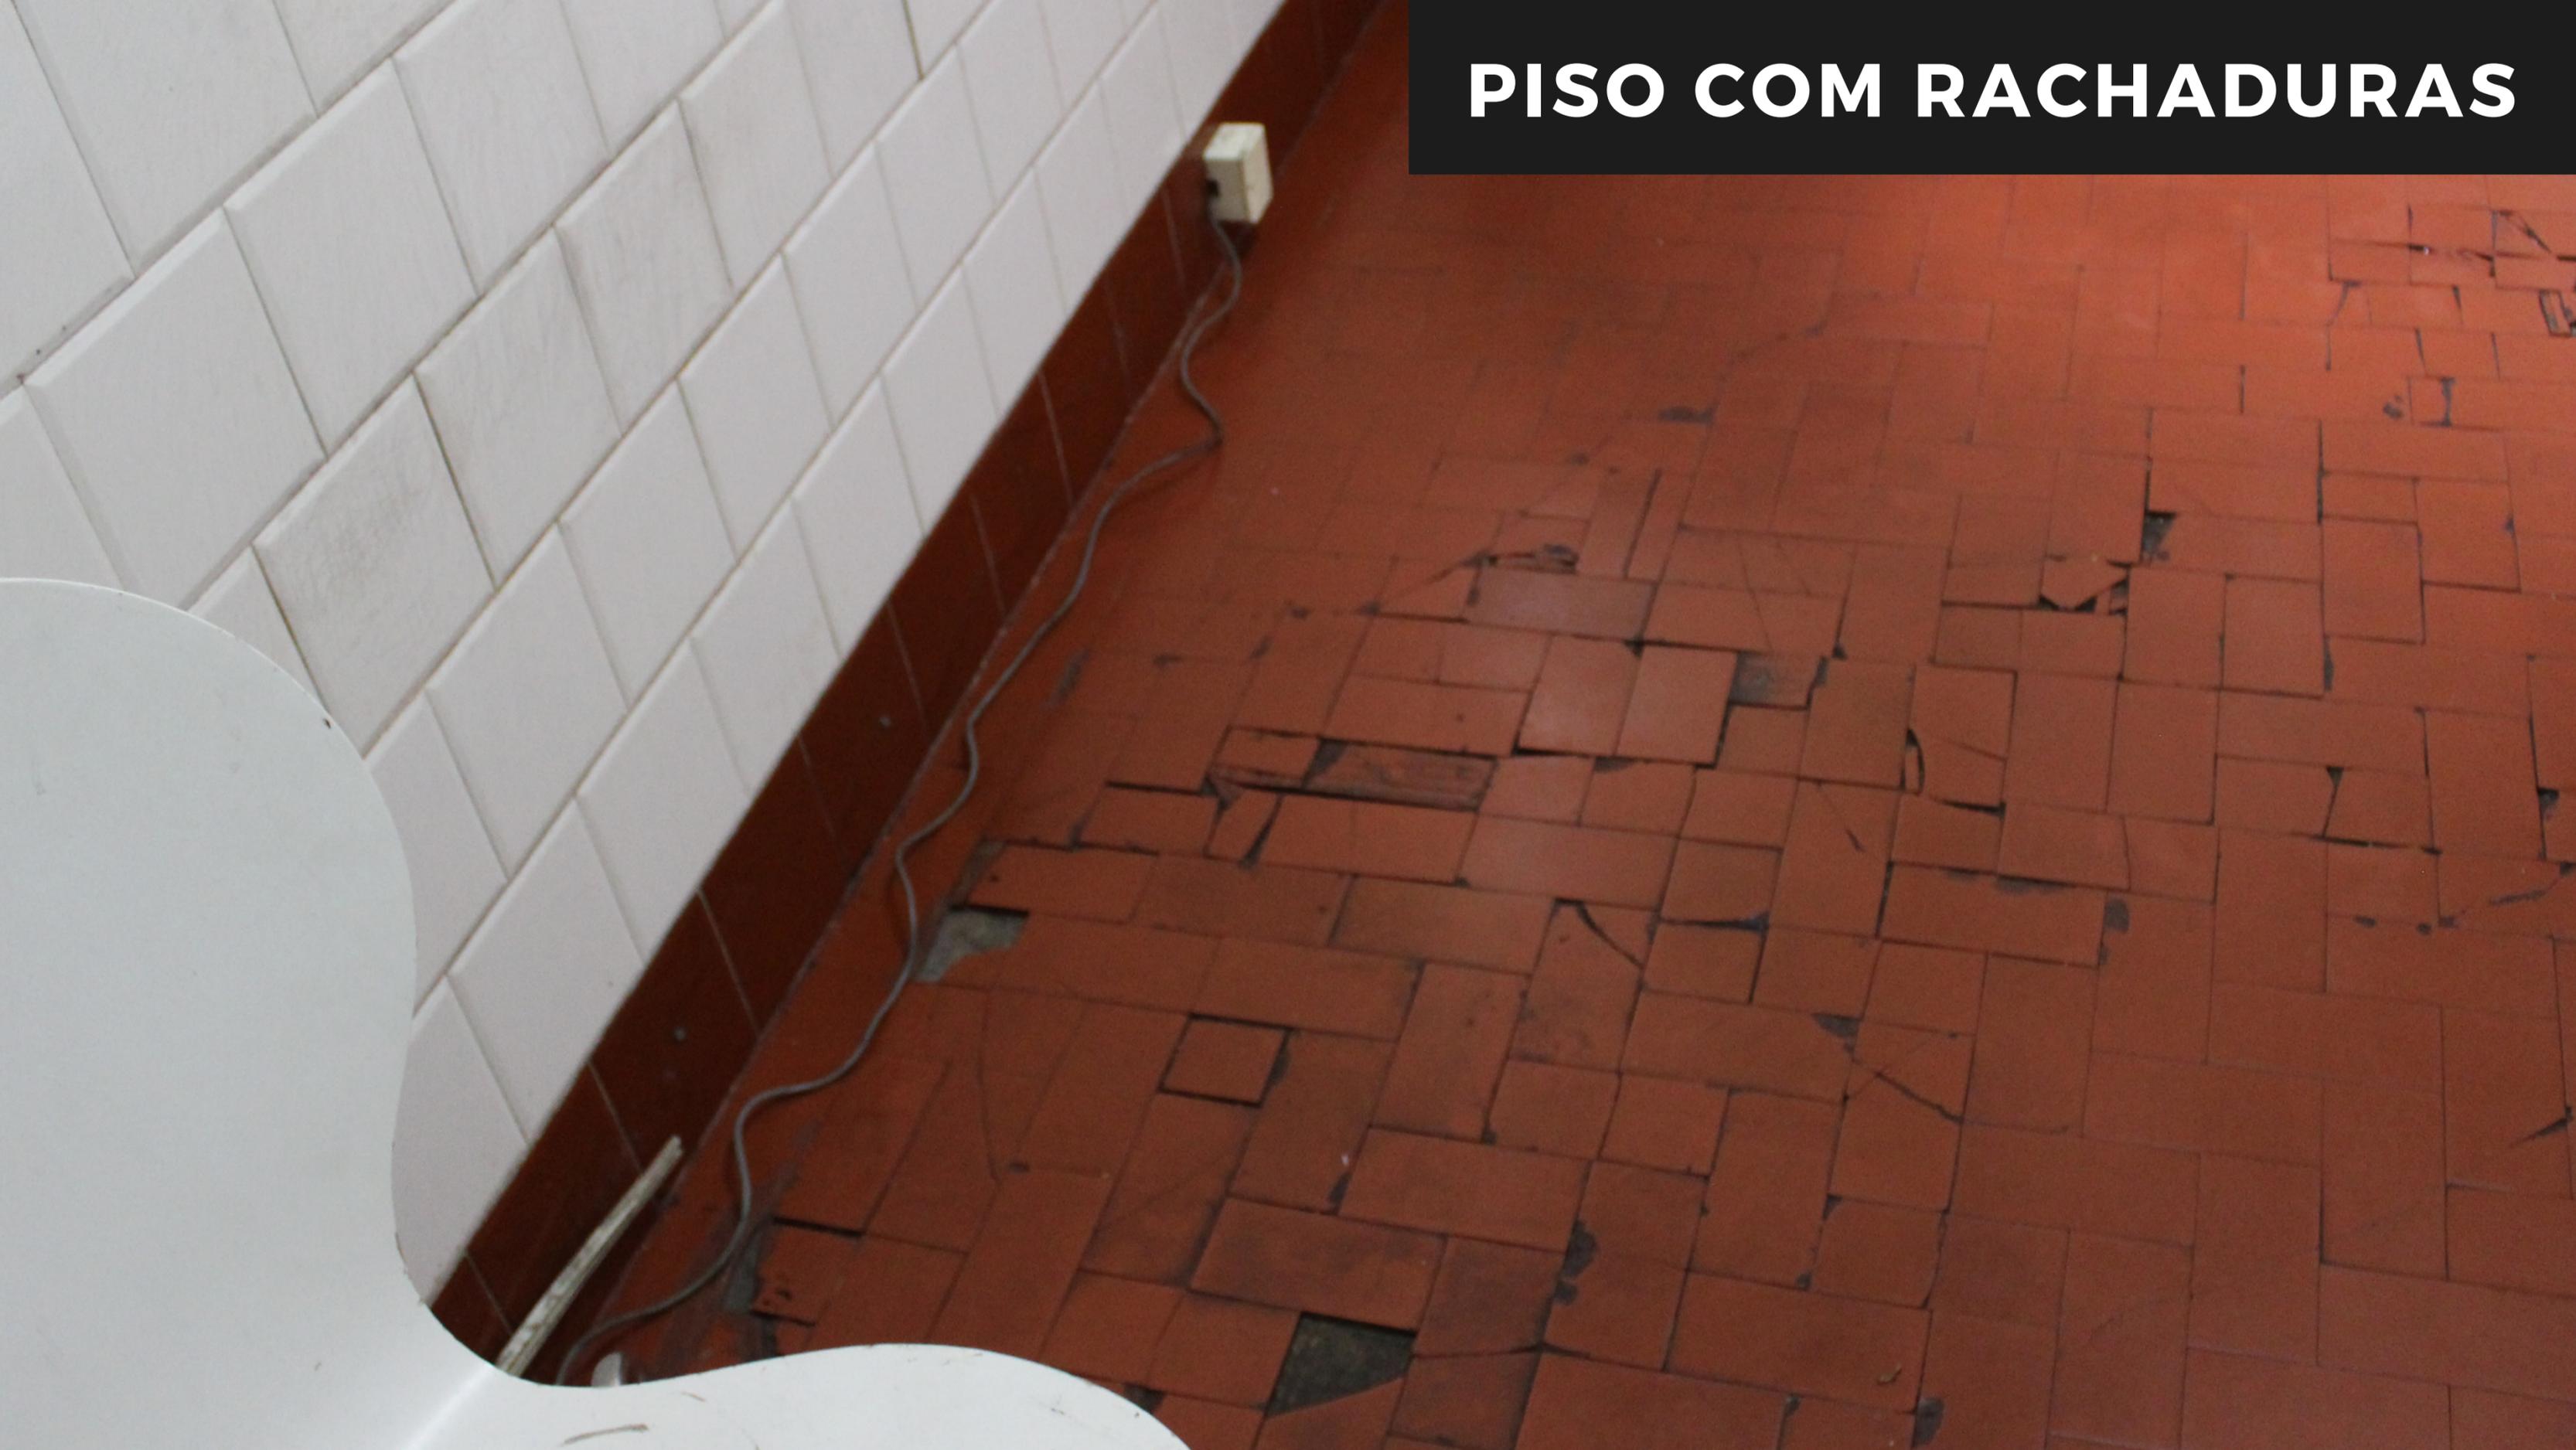
PISO COM RACHADURAS

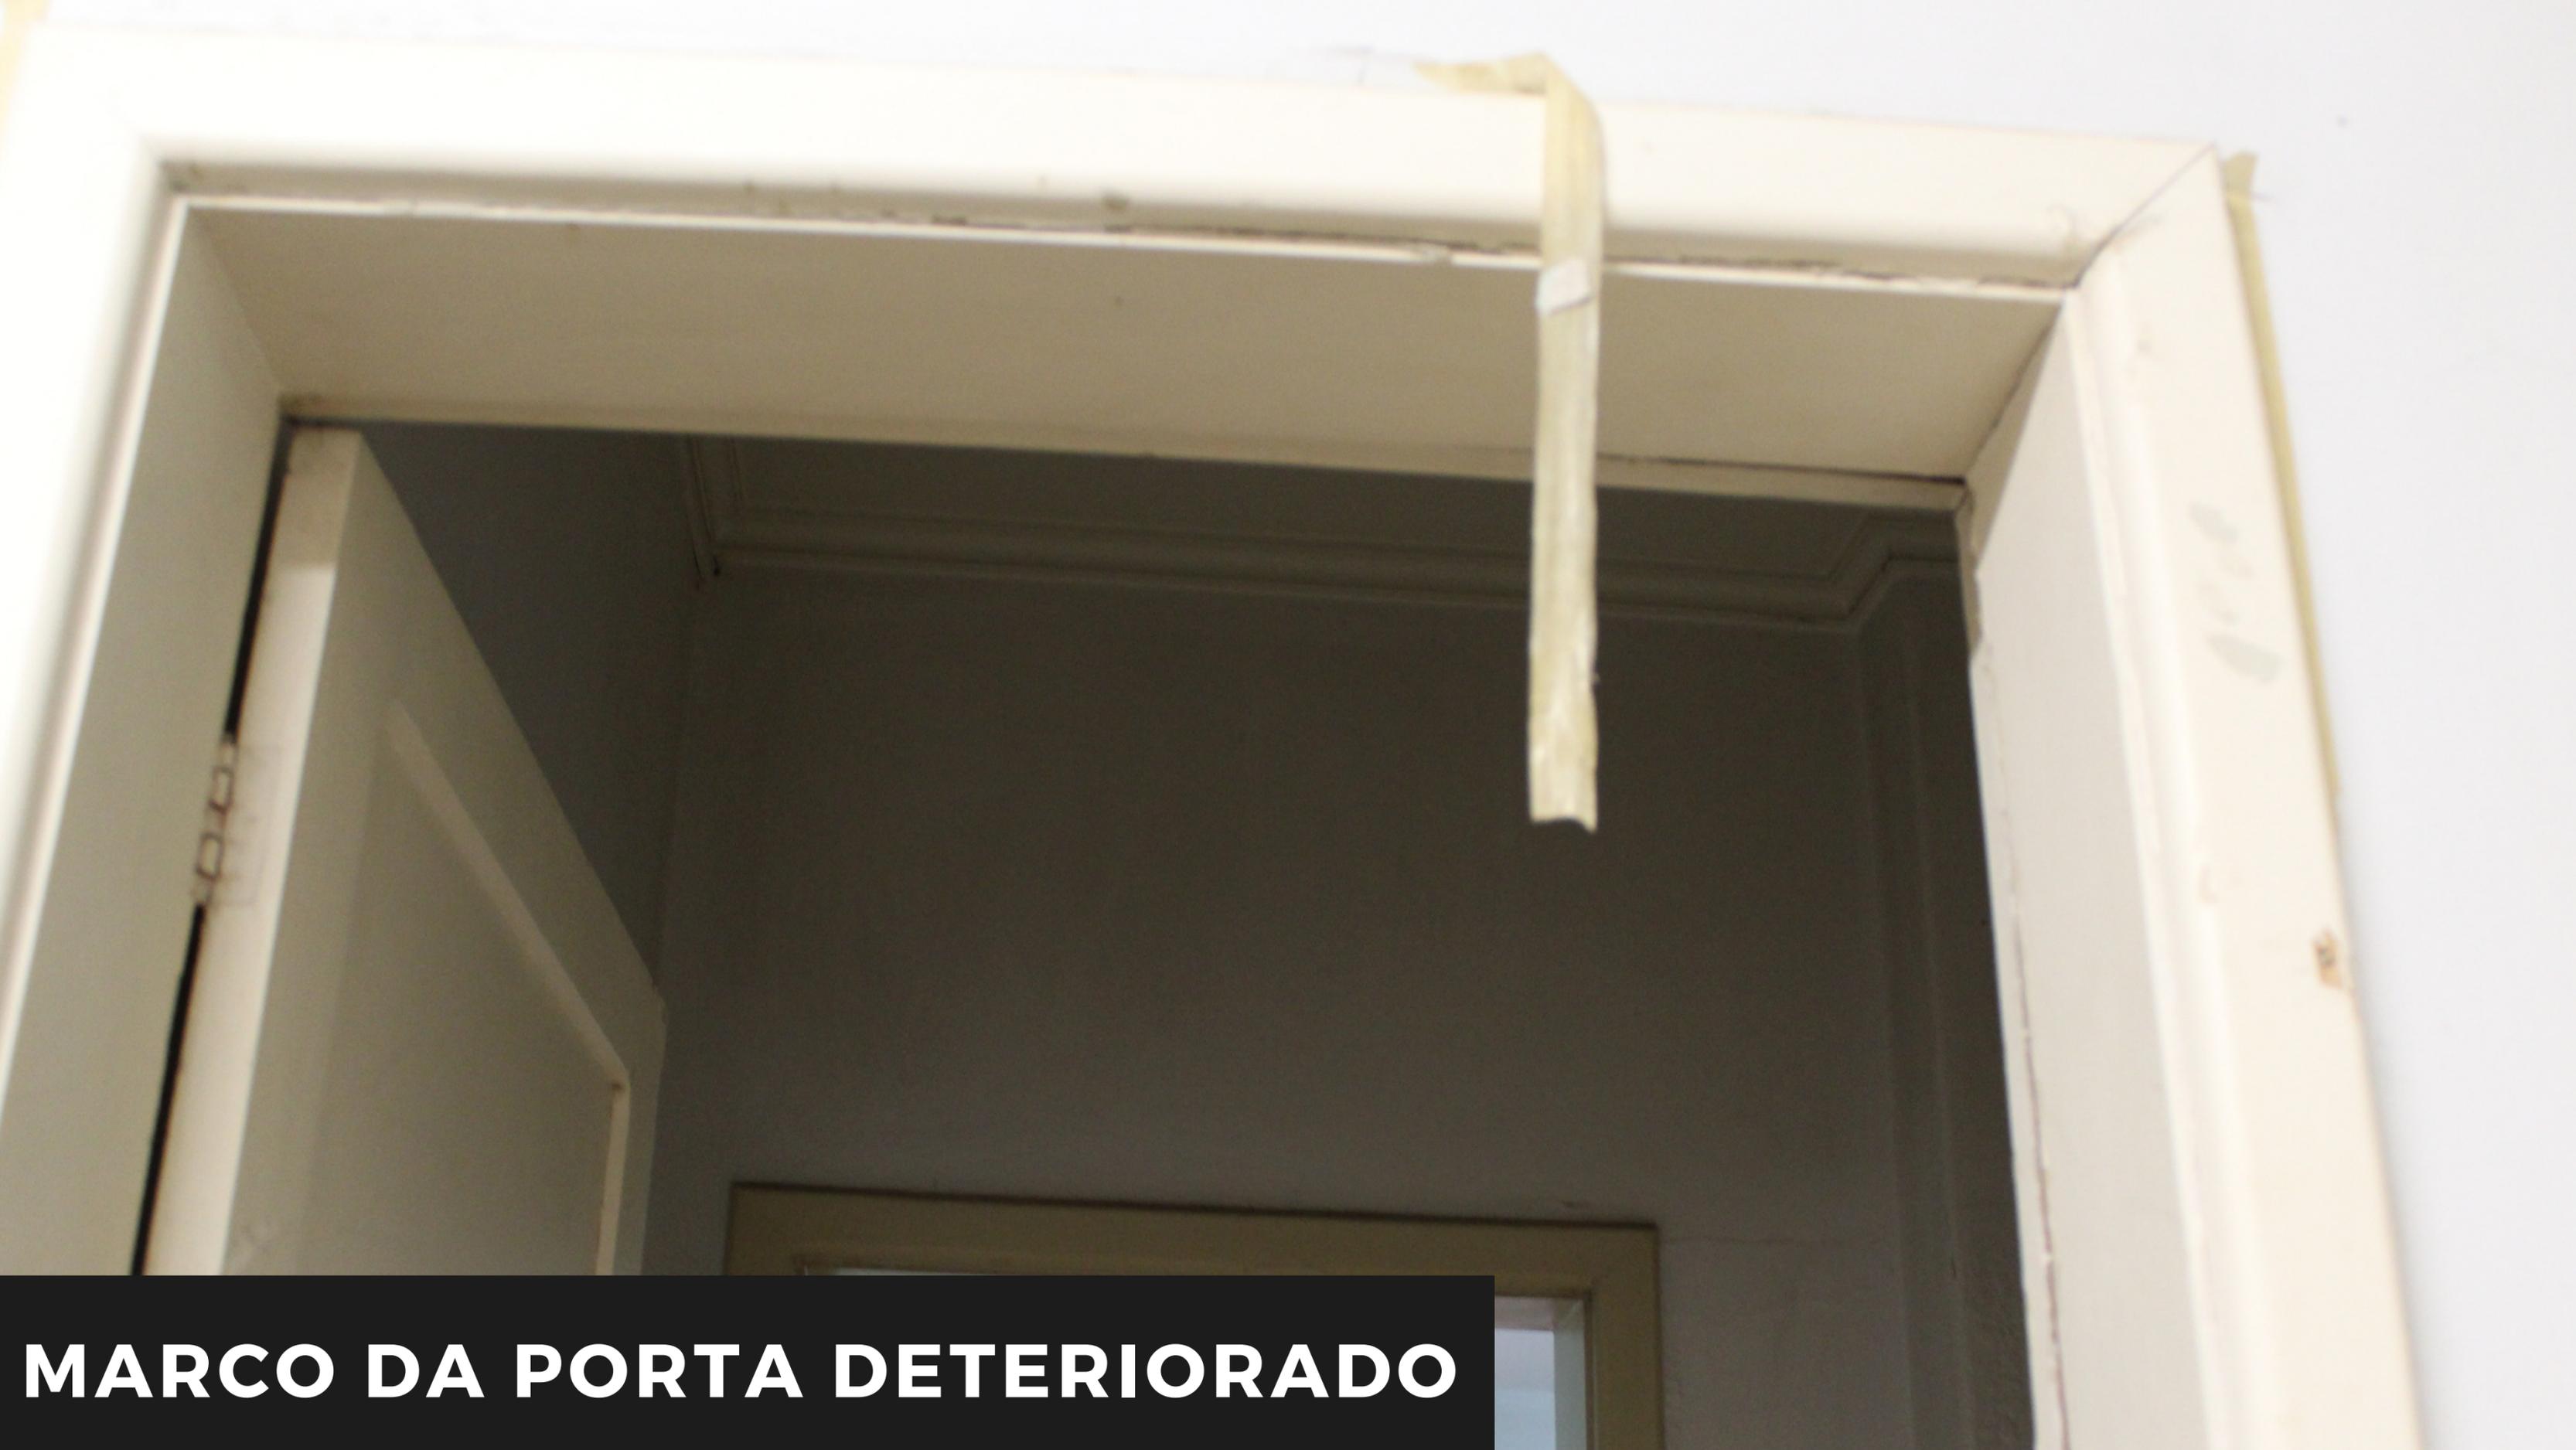
MARCO DA PORTA DETERIORADO

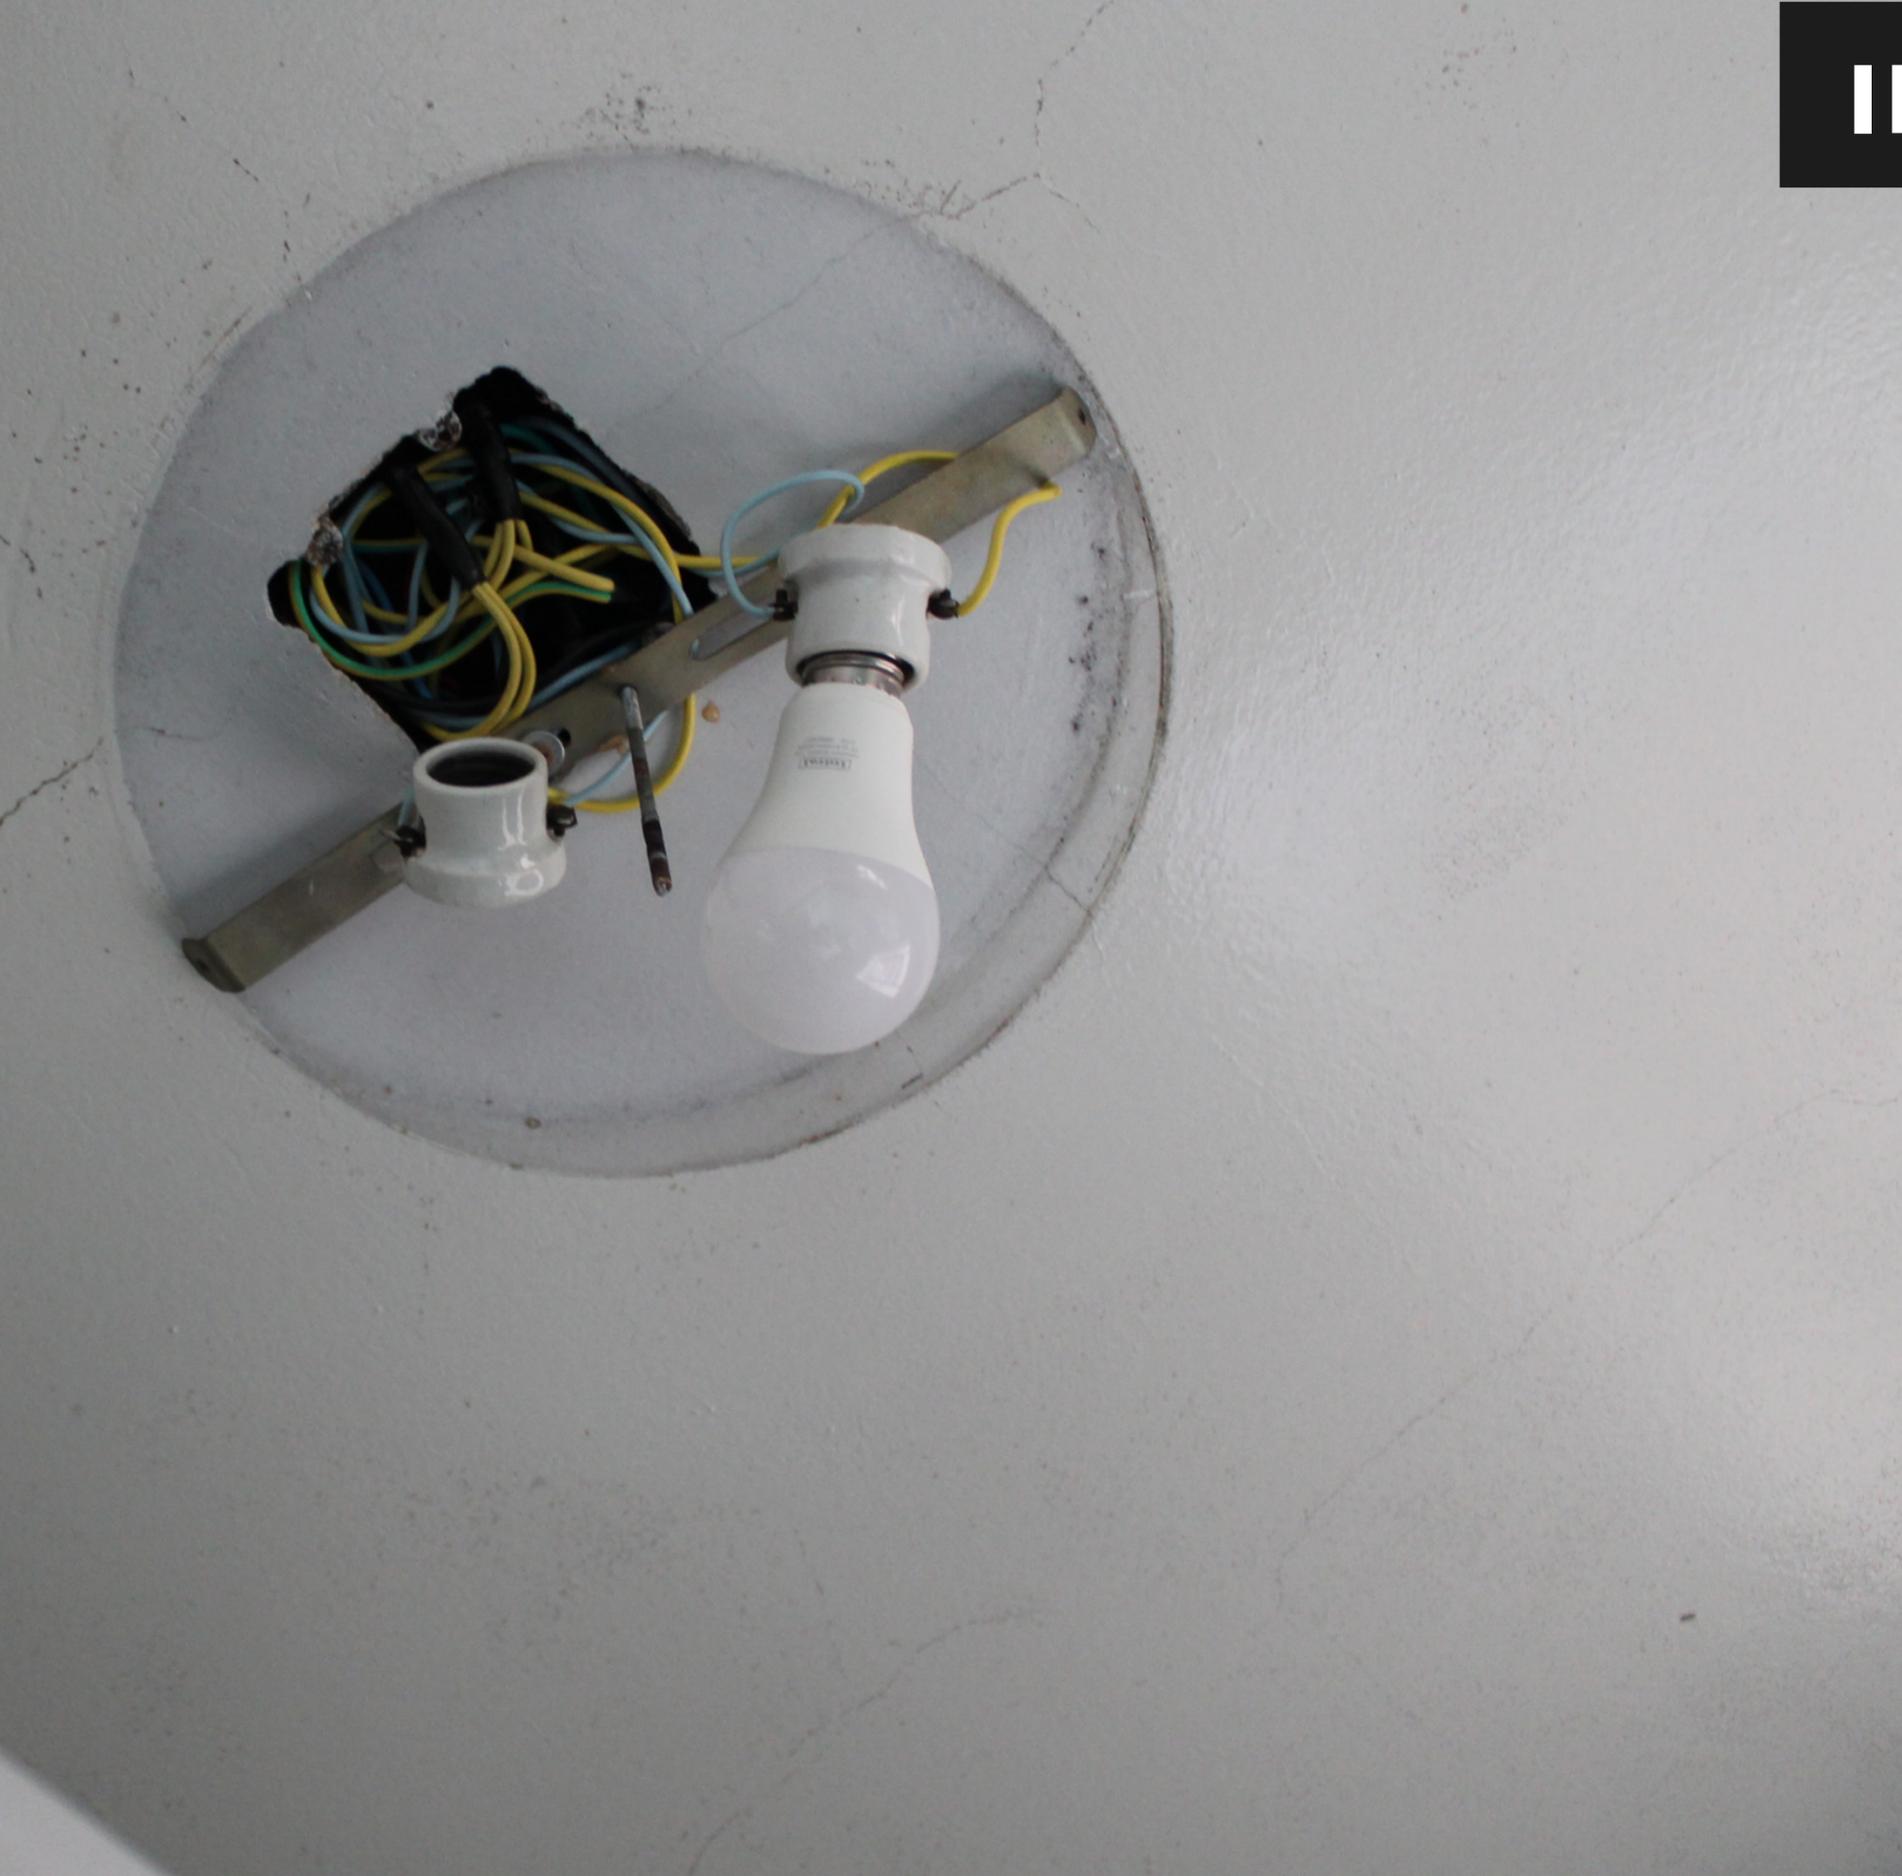
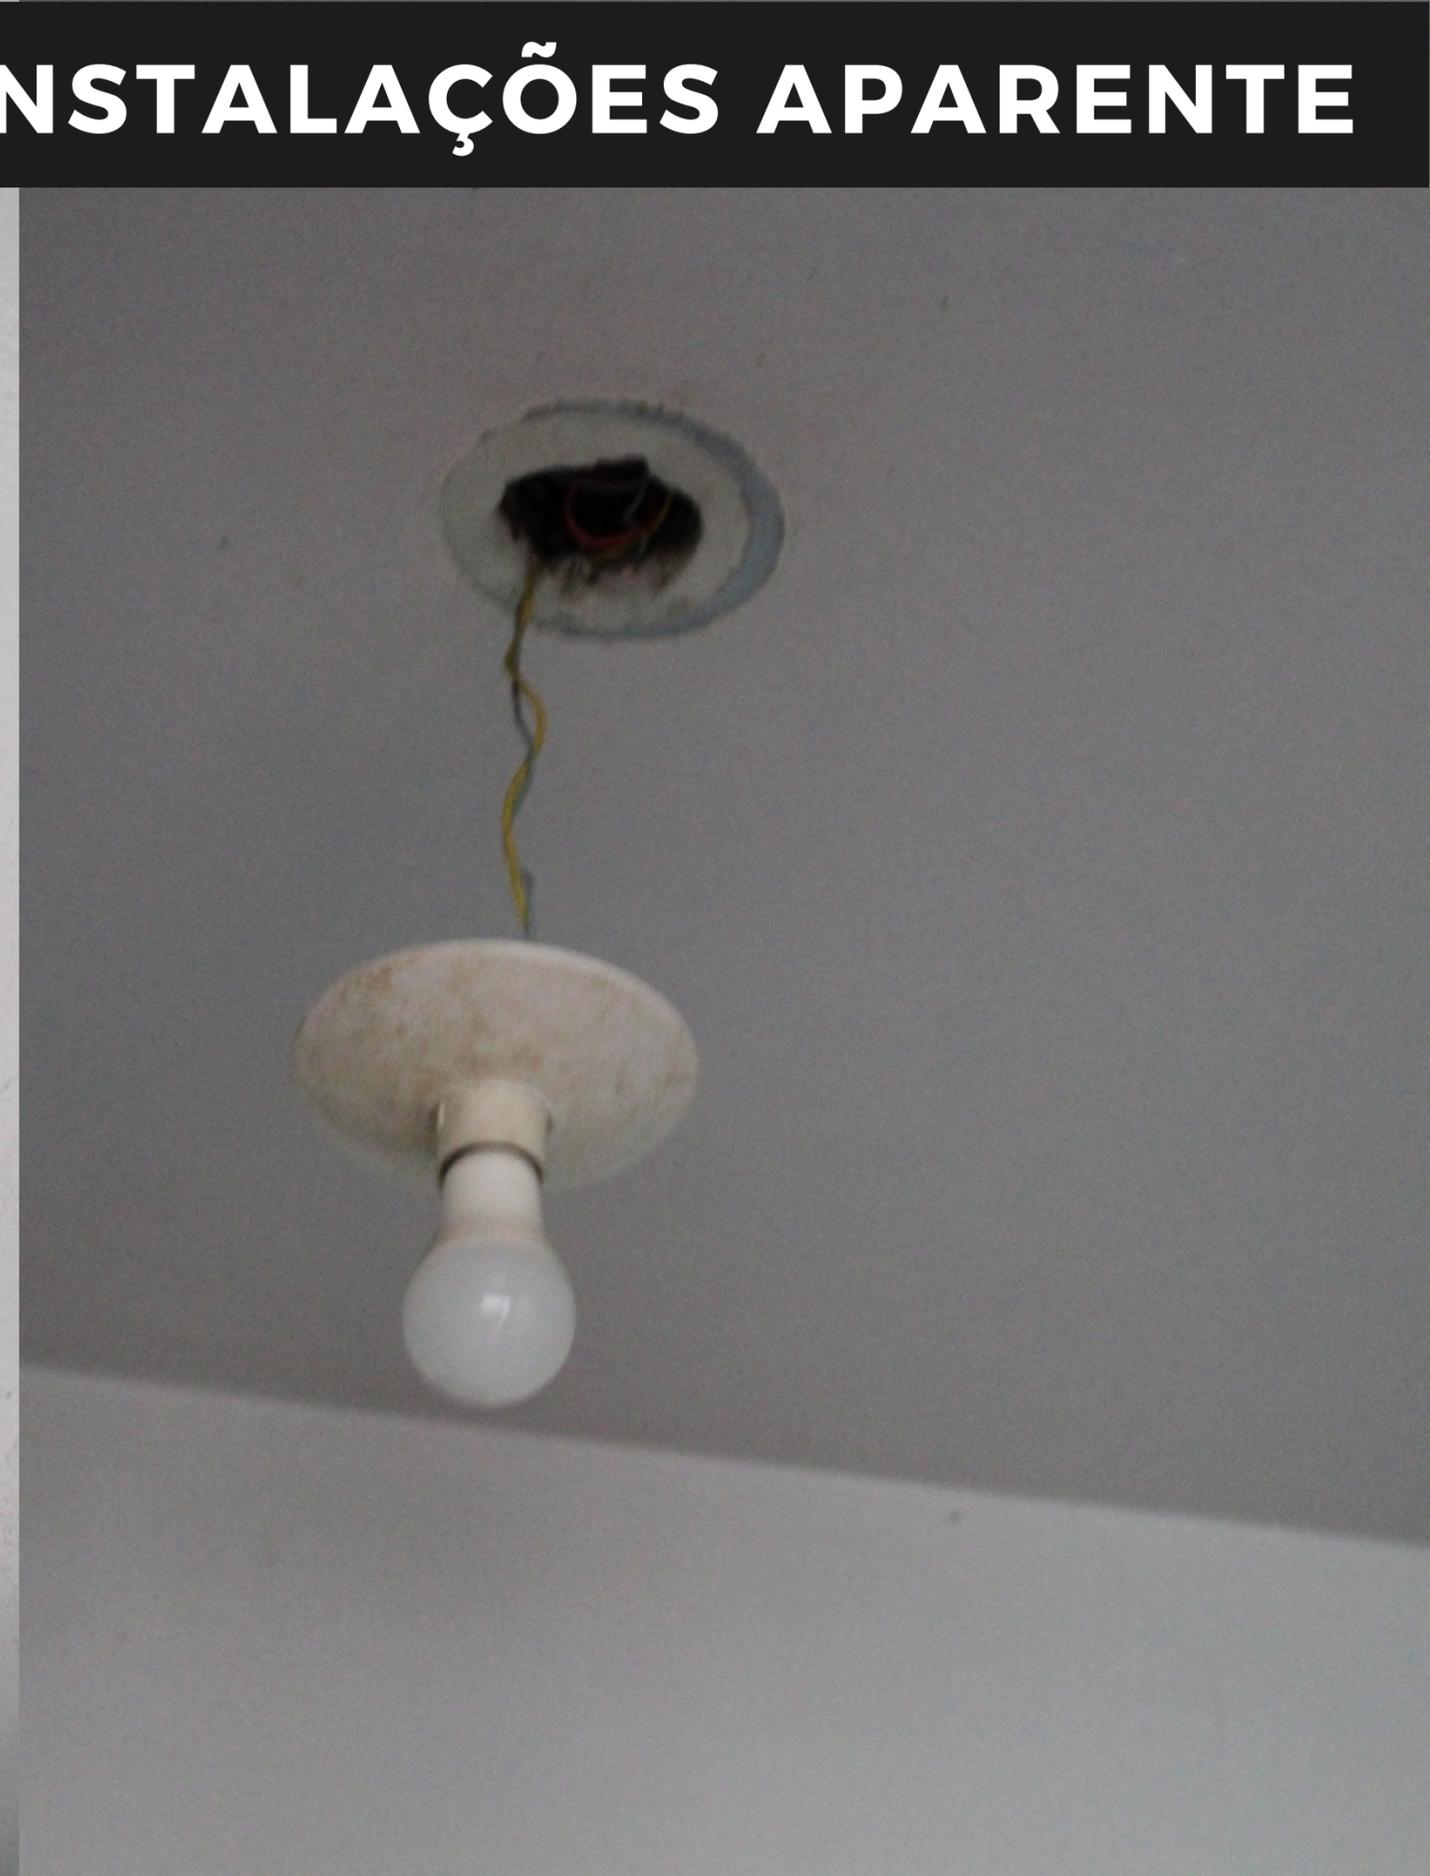
INSTALAÇÕES APARENTE
