UNIDADE DE ACOLHIMENTO

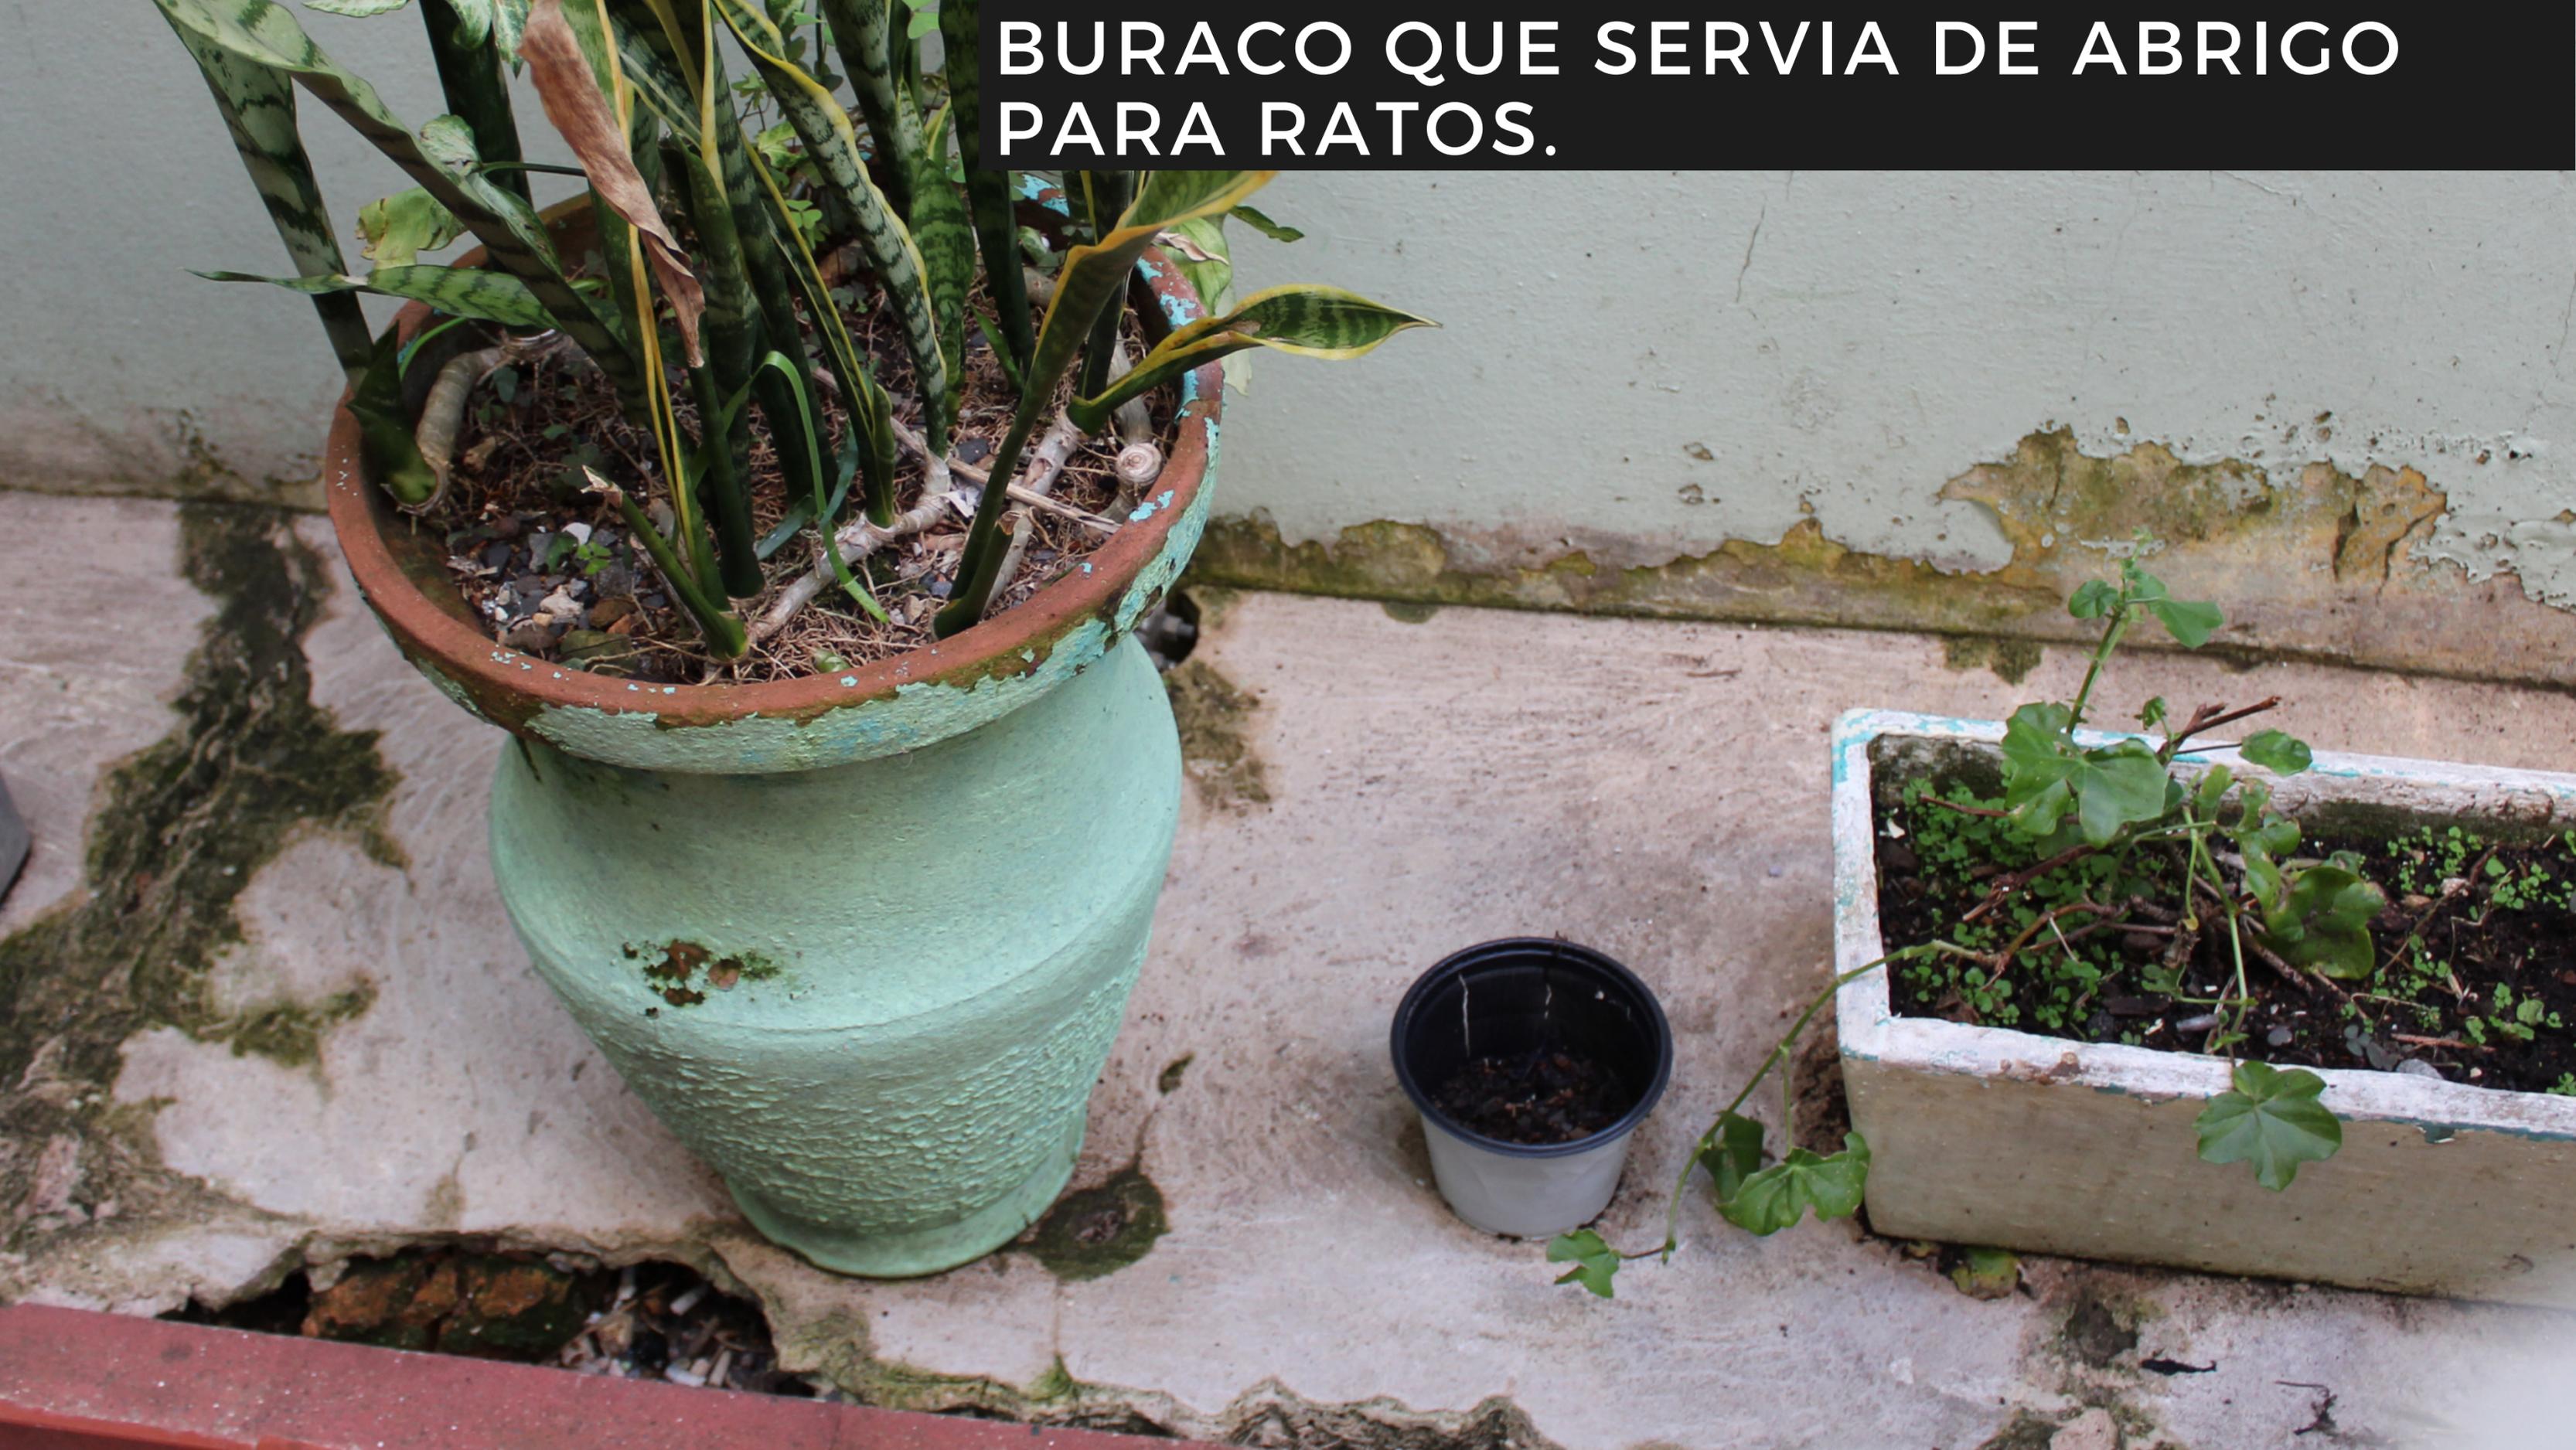
**BURACO QUE SERVIA DE ABRIGO
PARA RATOS.**

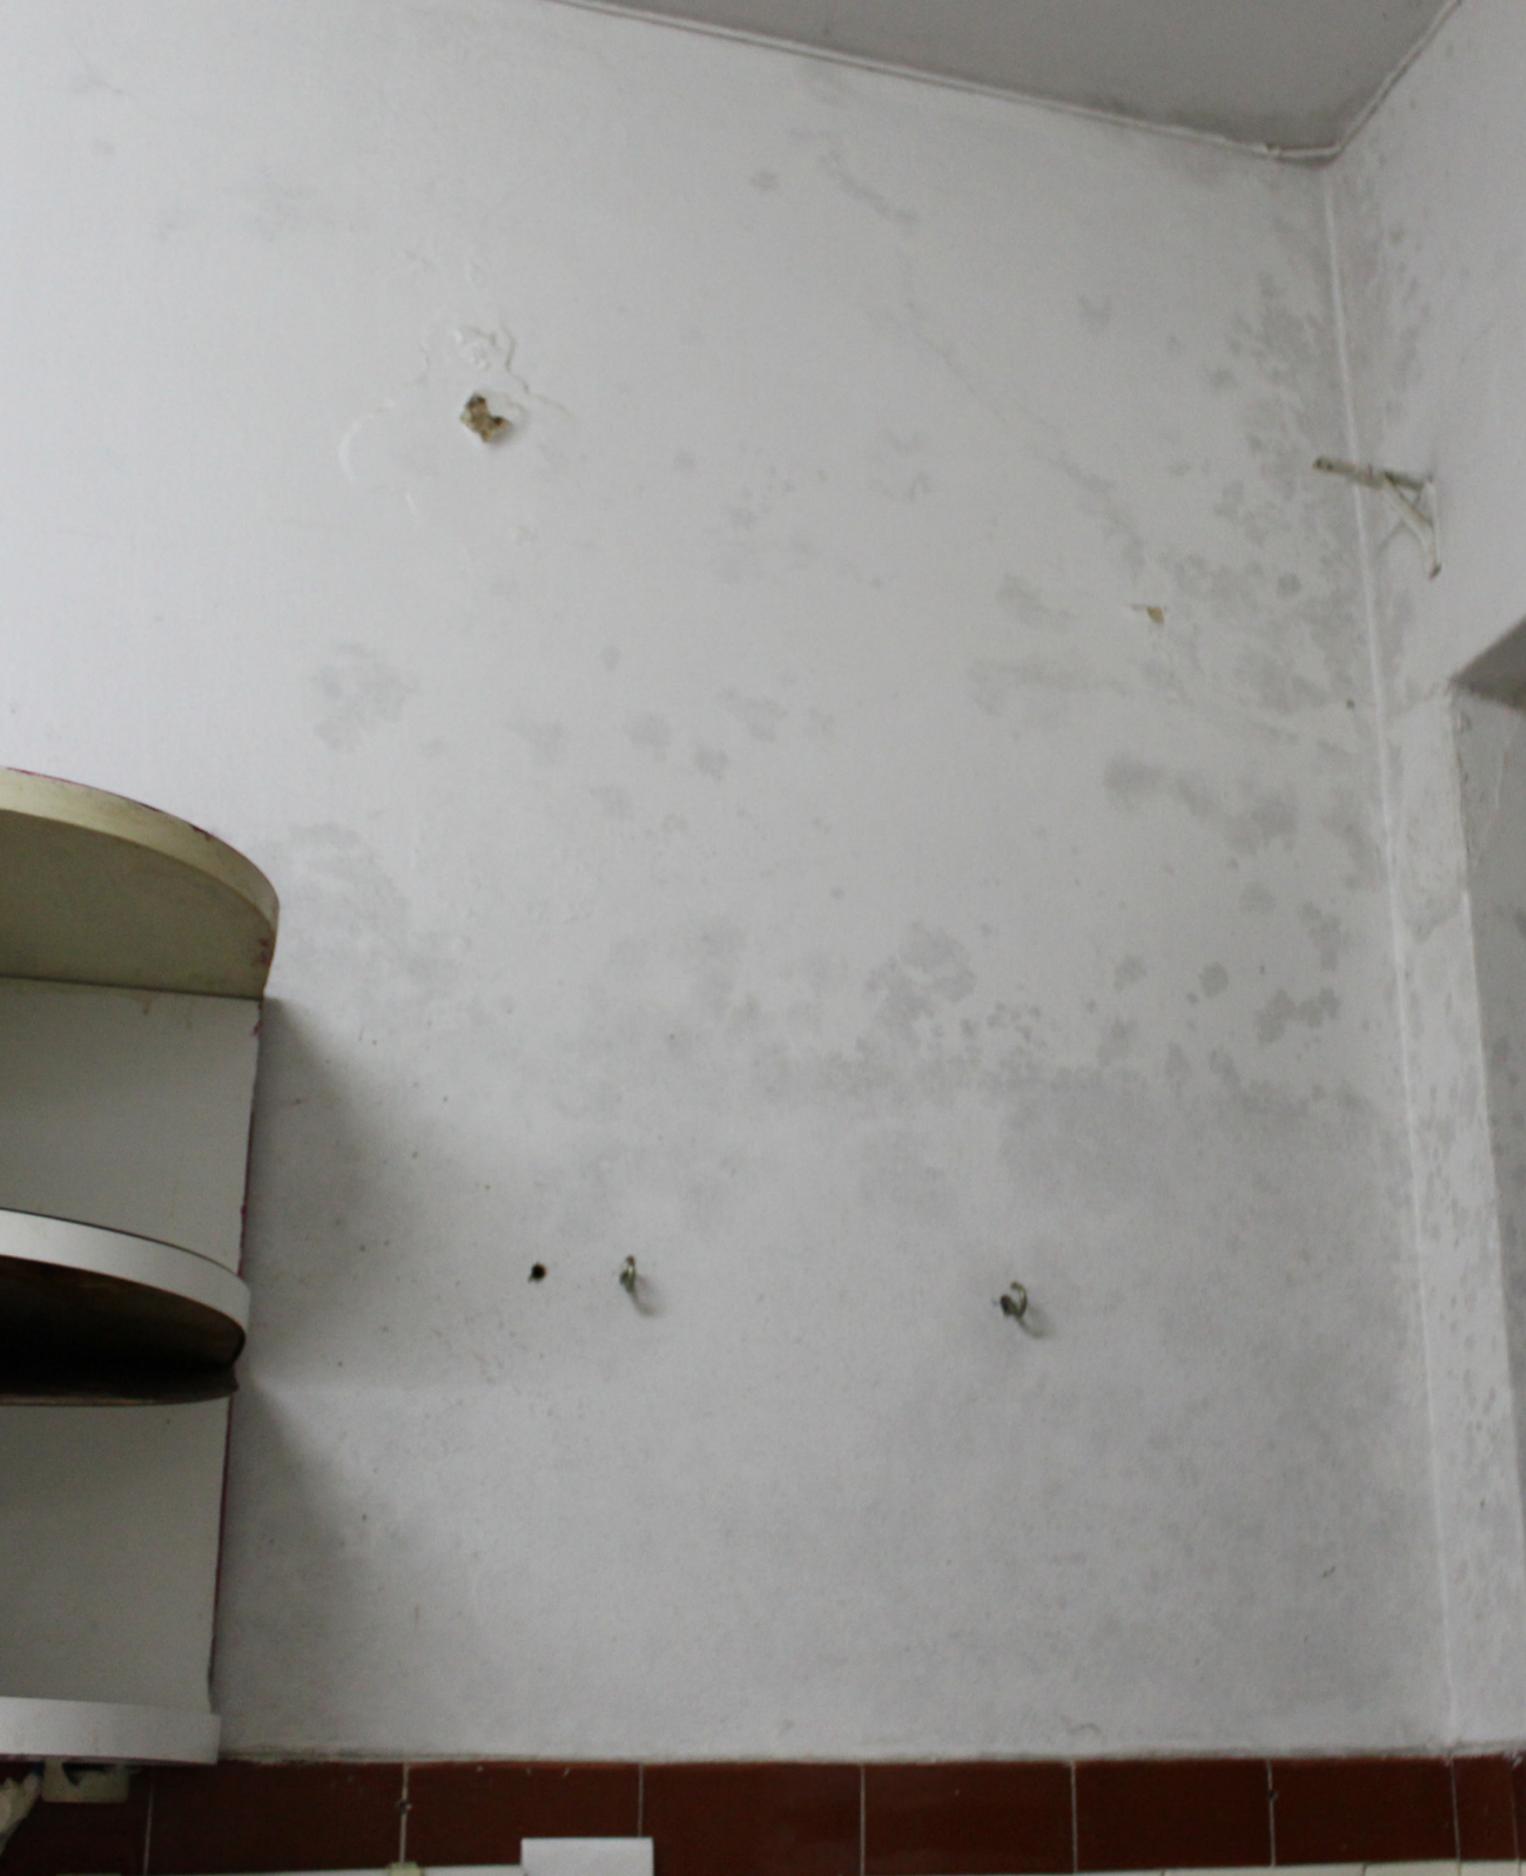
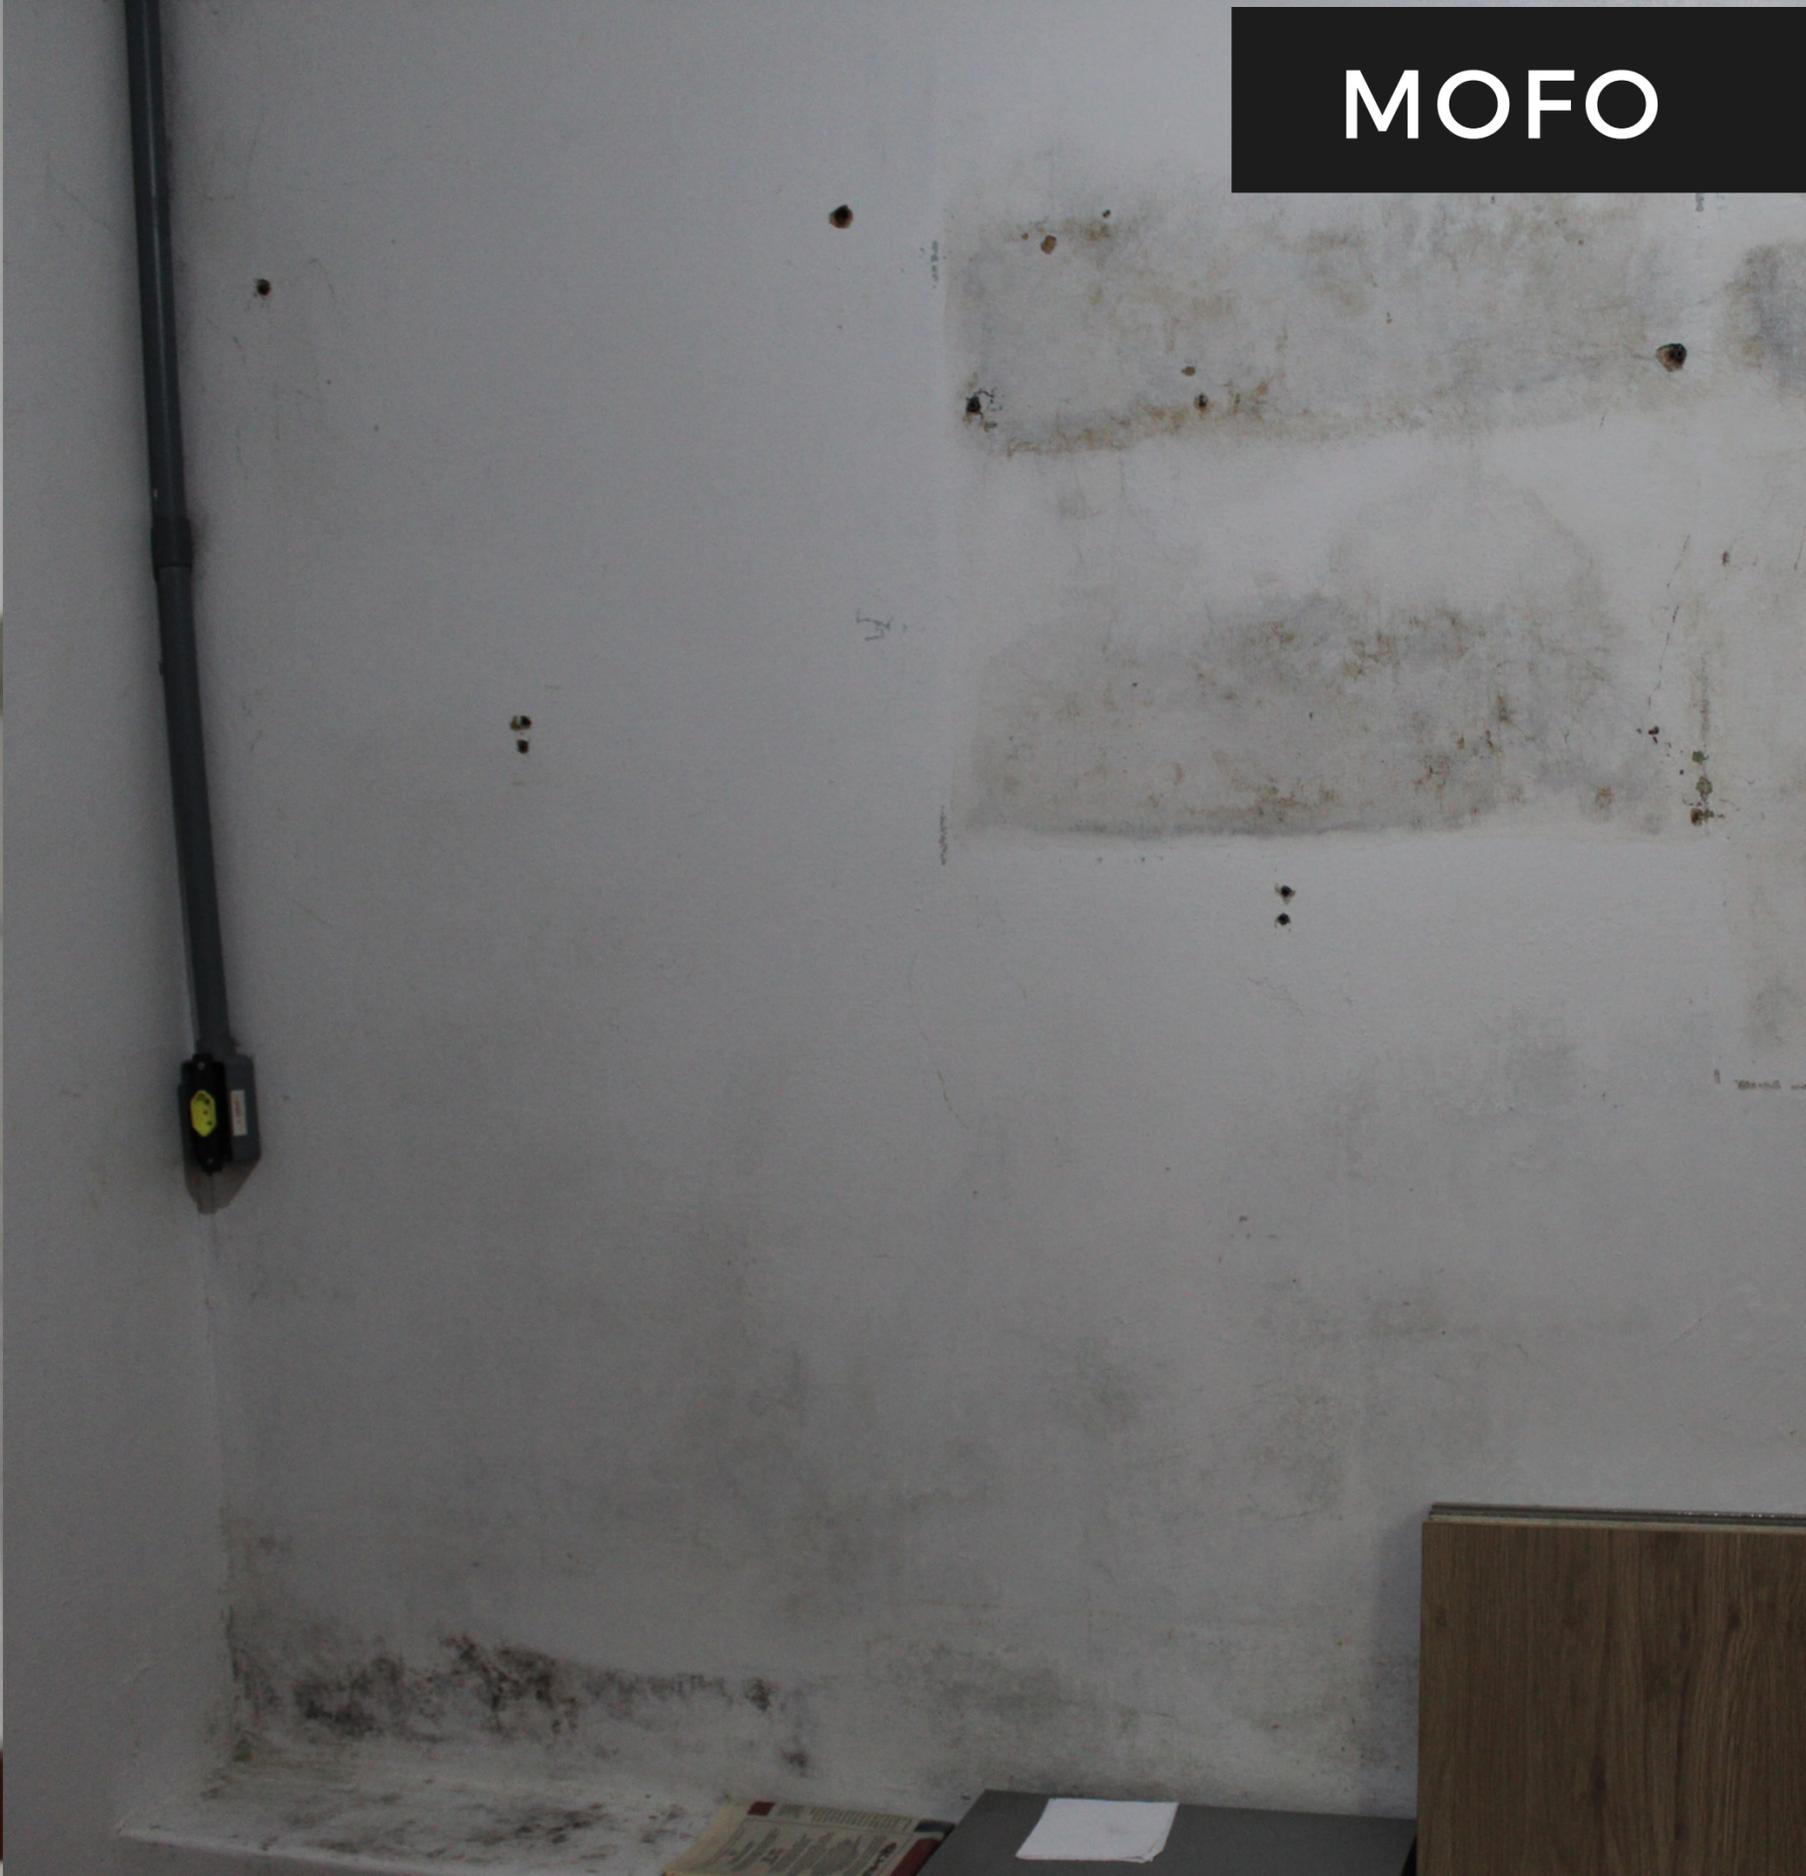
MOFO

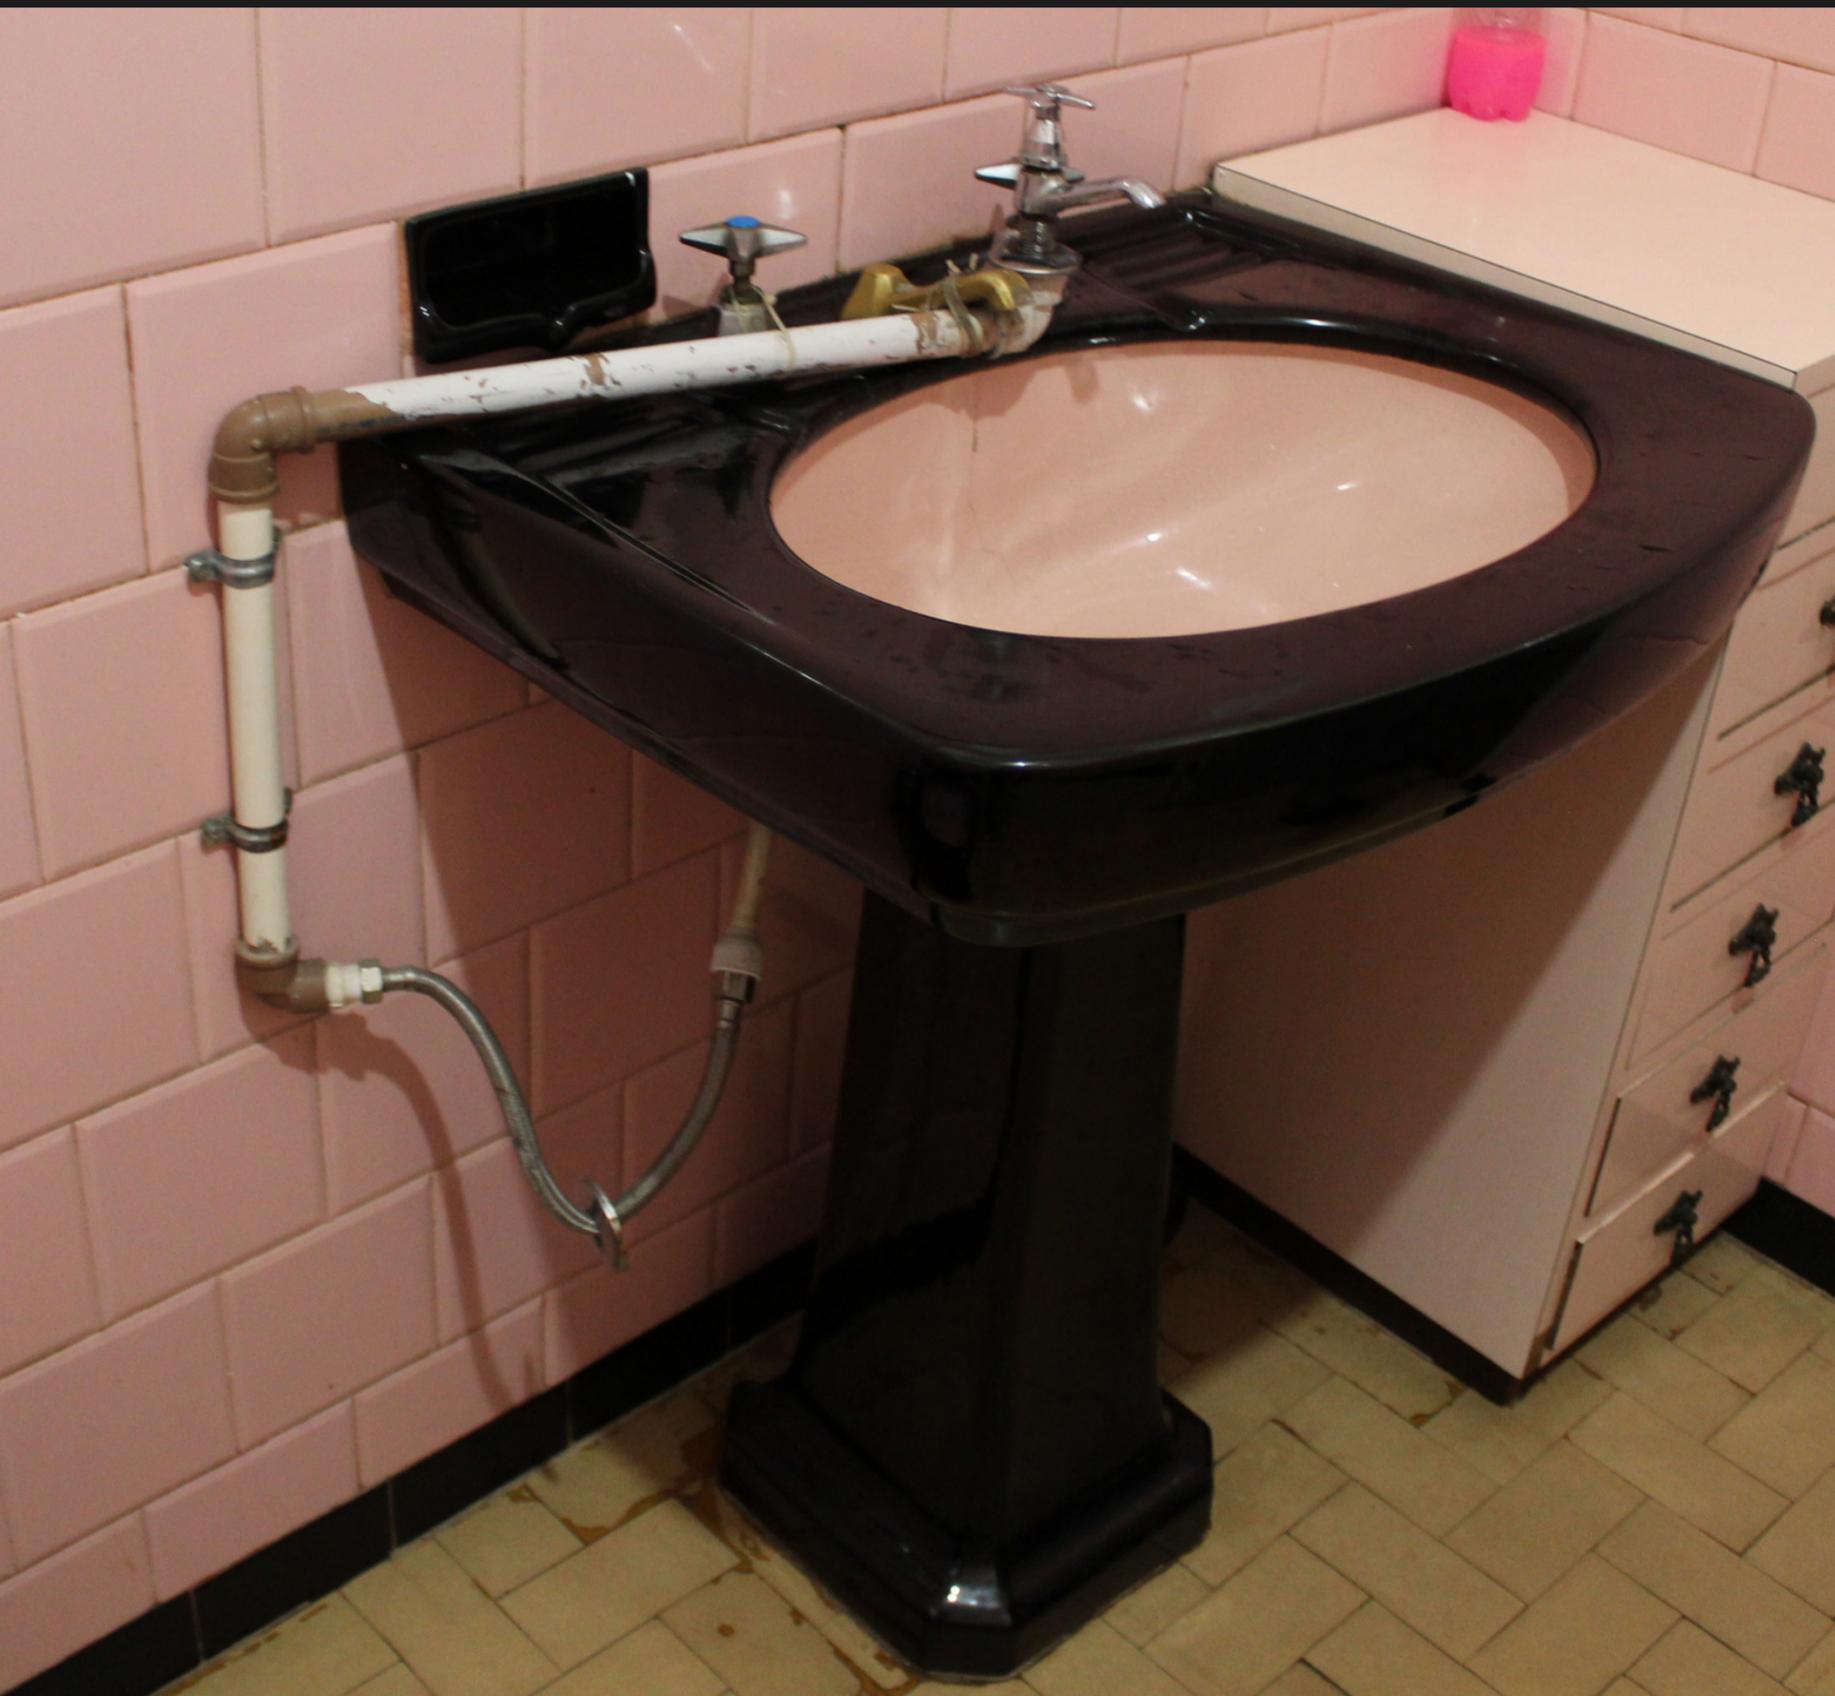
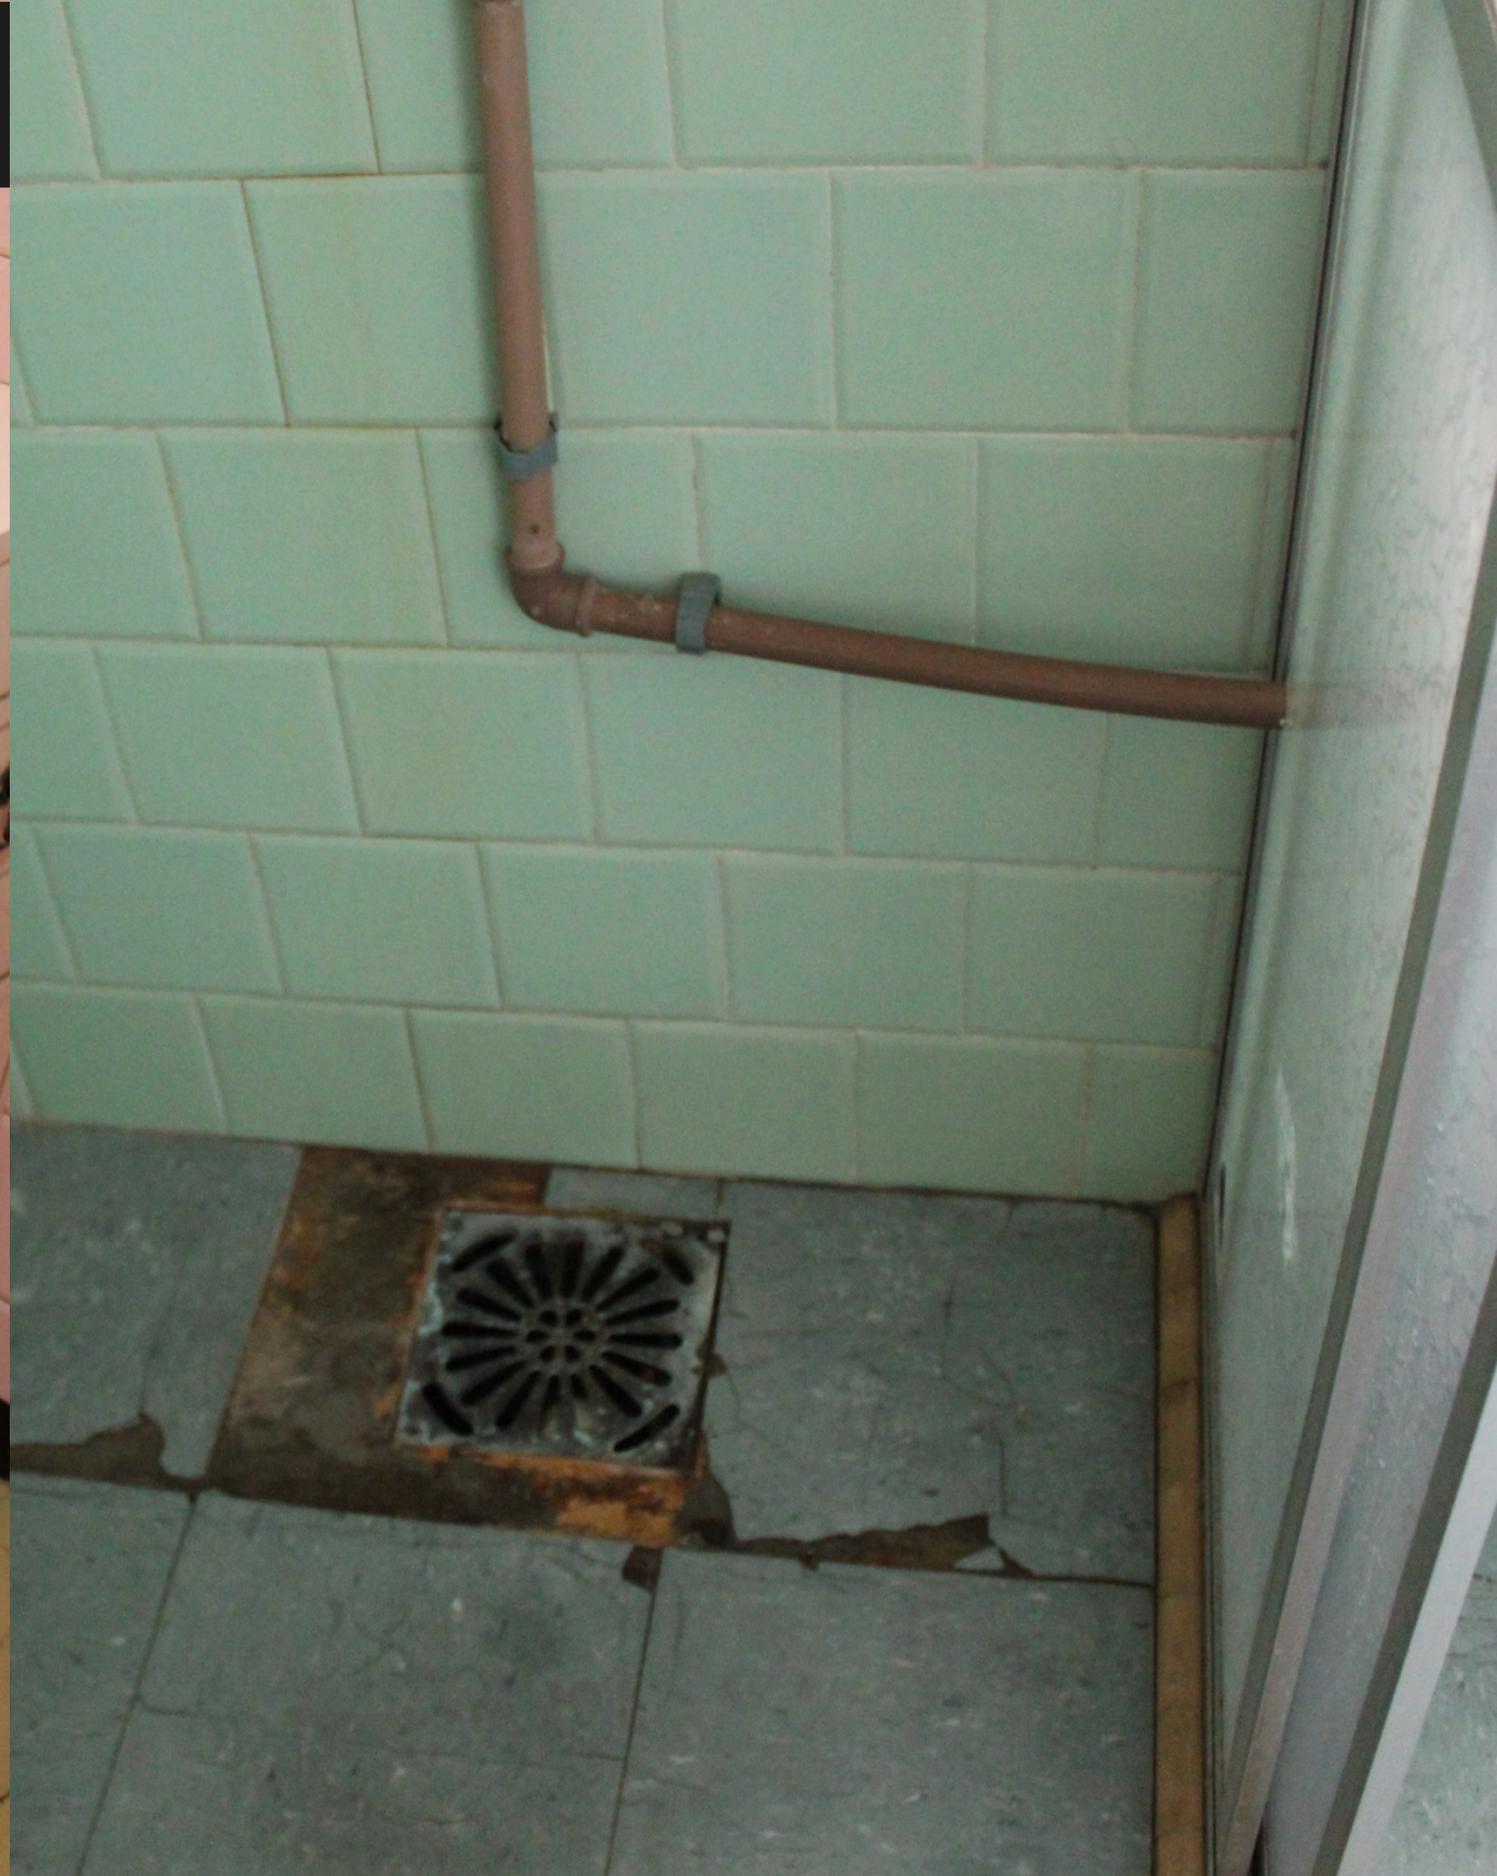
BANHEIROS COM PROBLEMAS

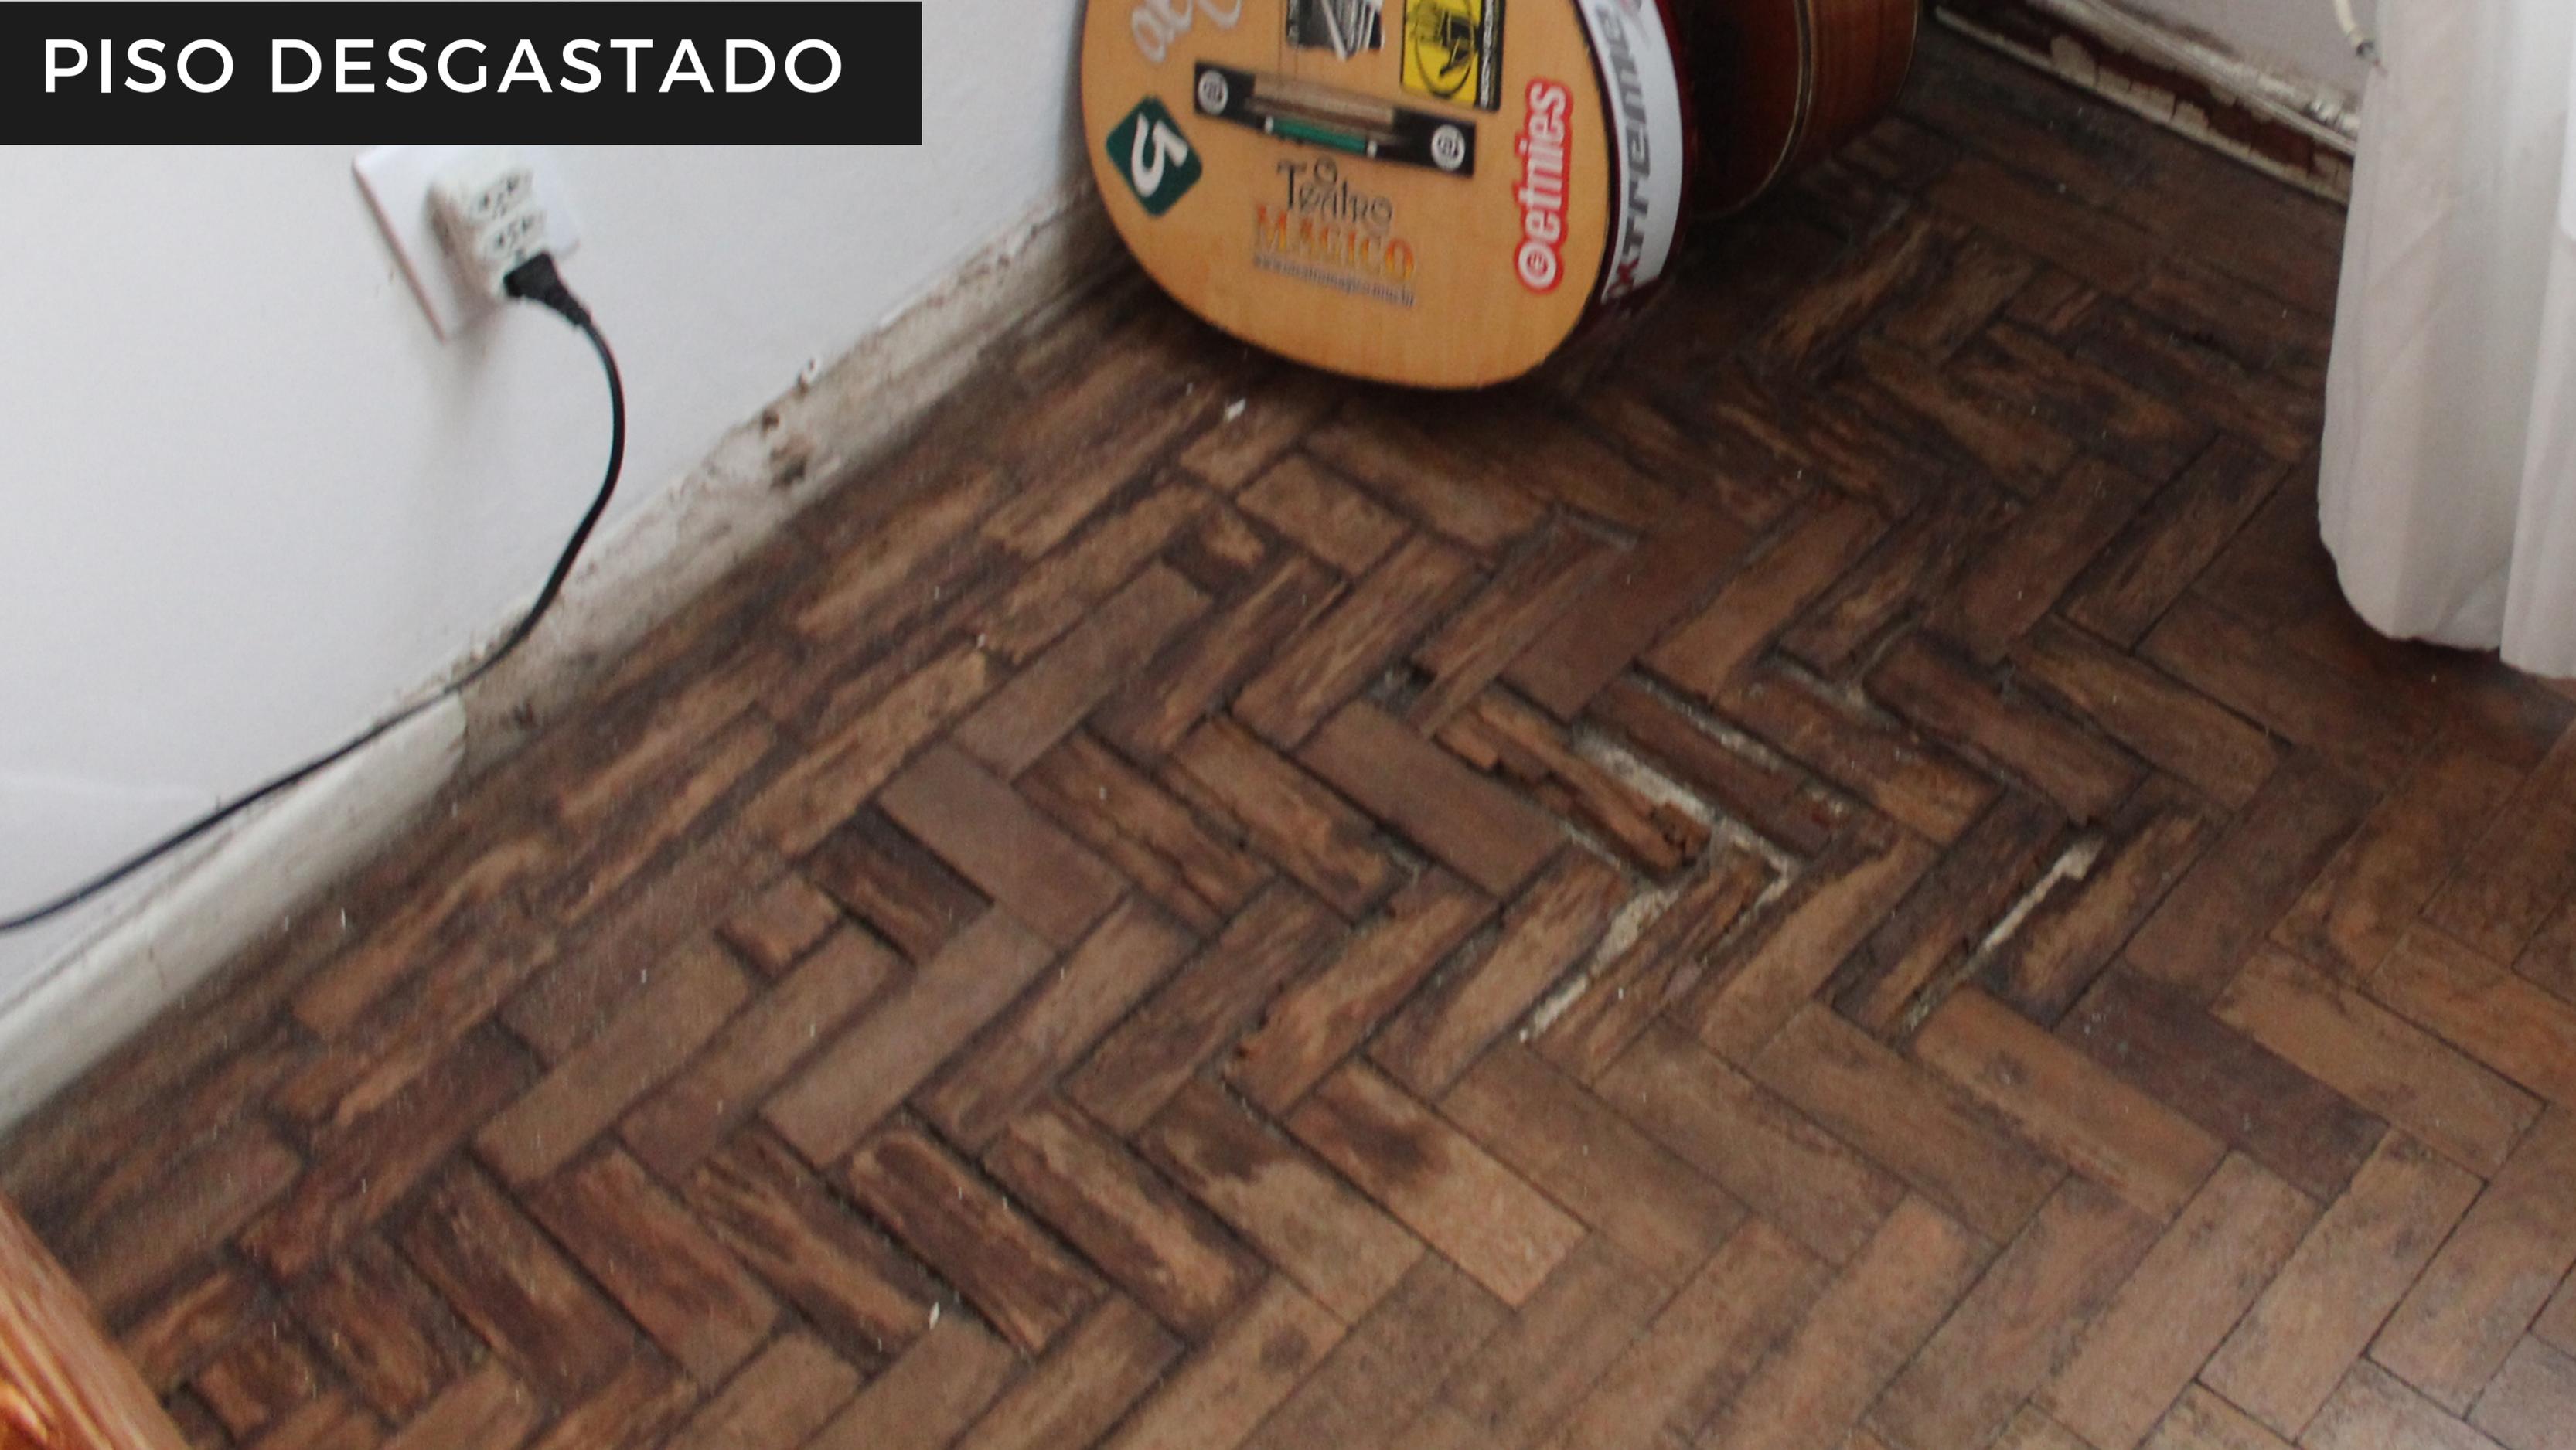
PISO DESGASTADO

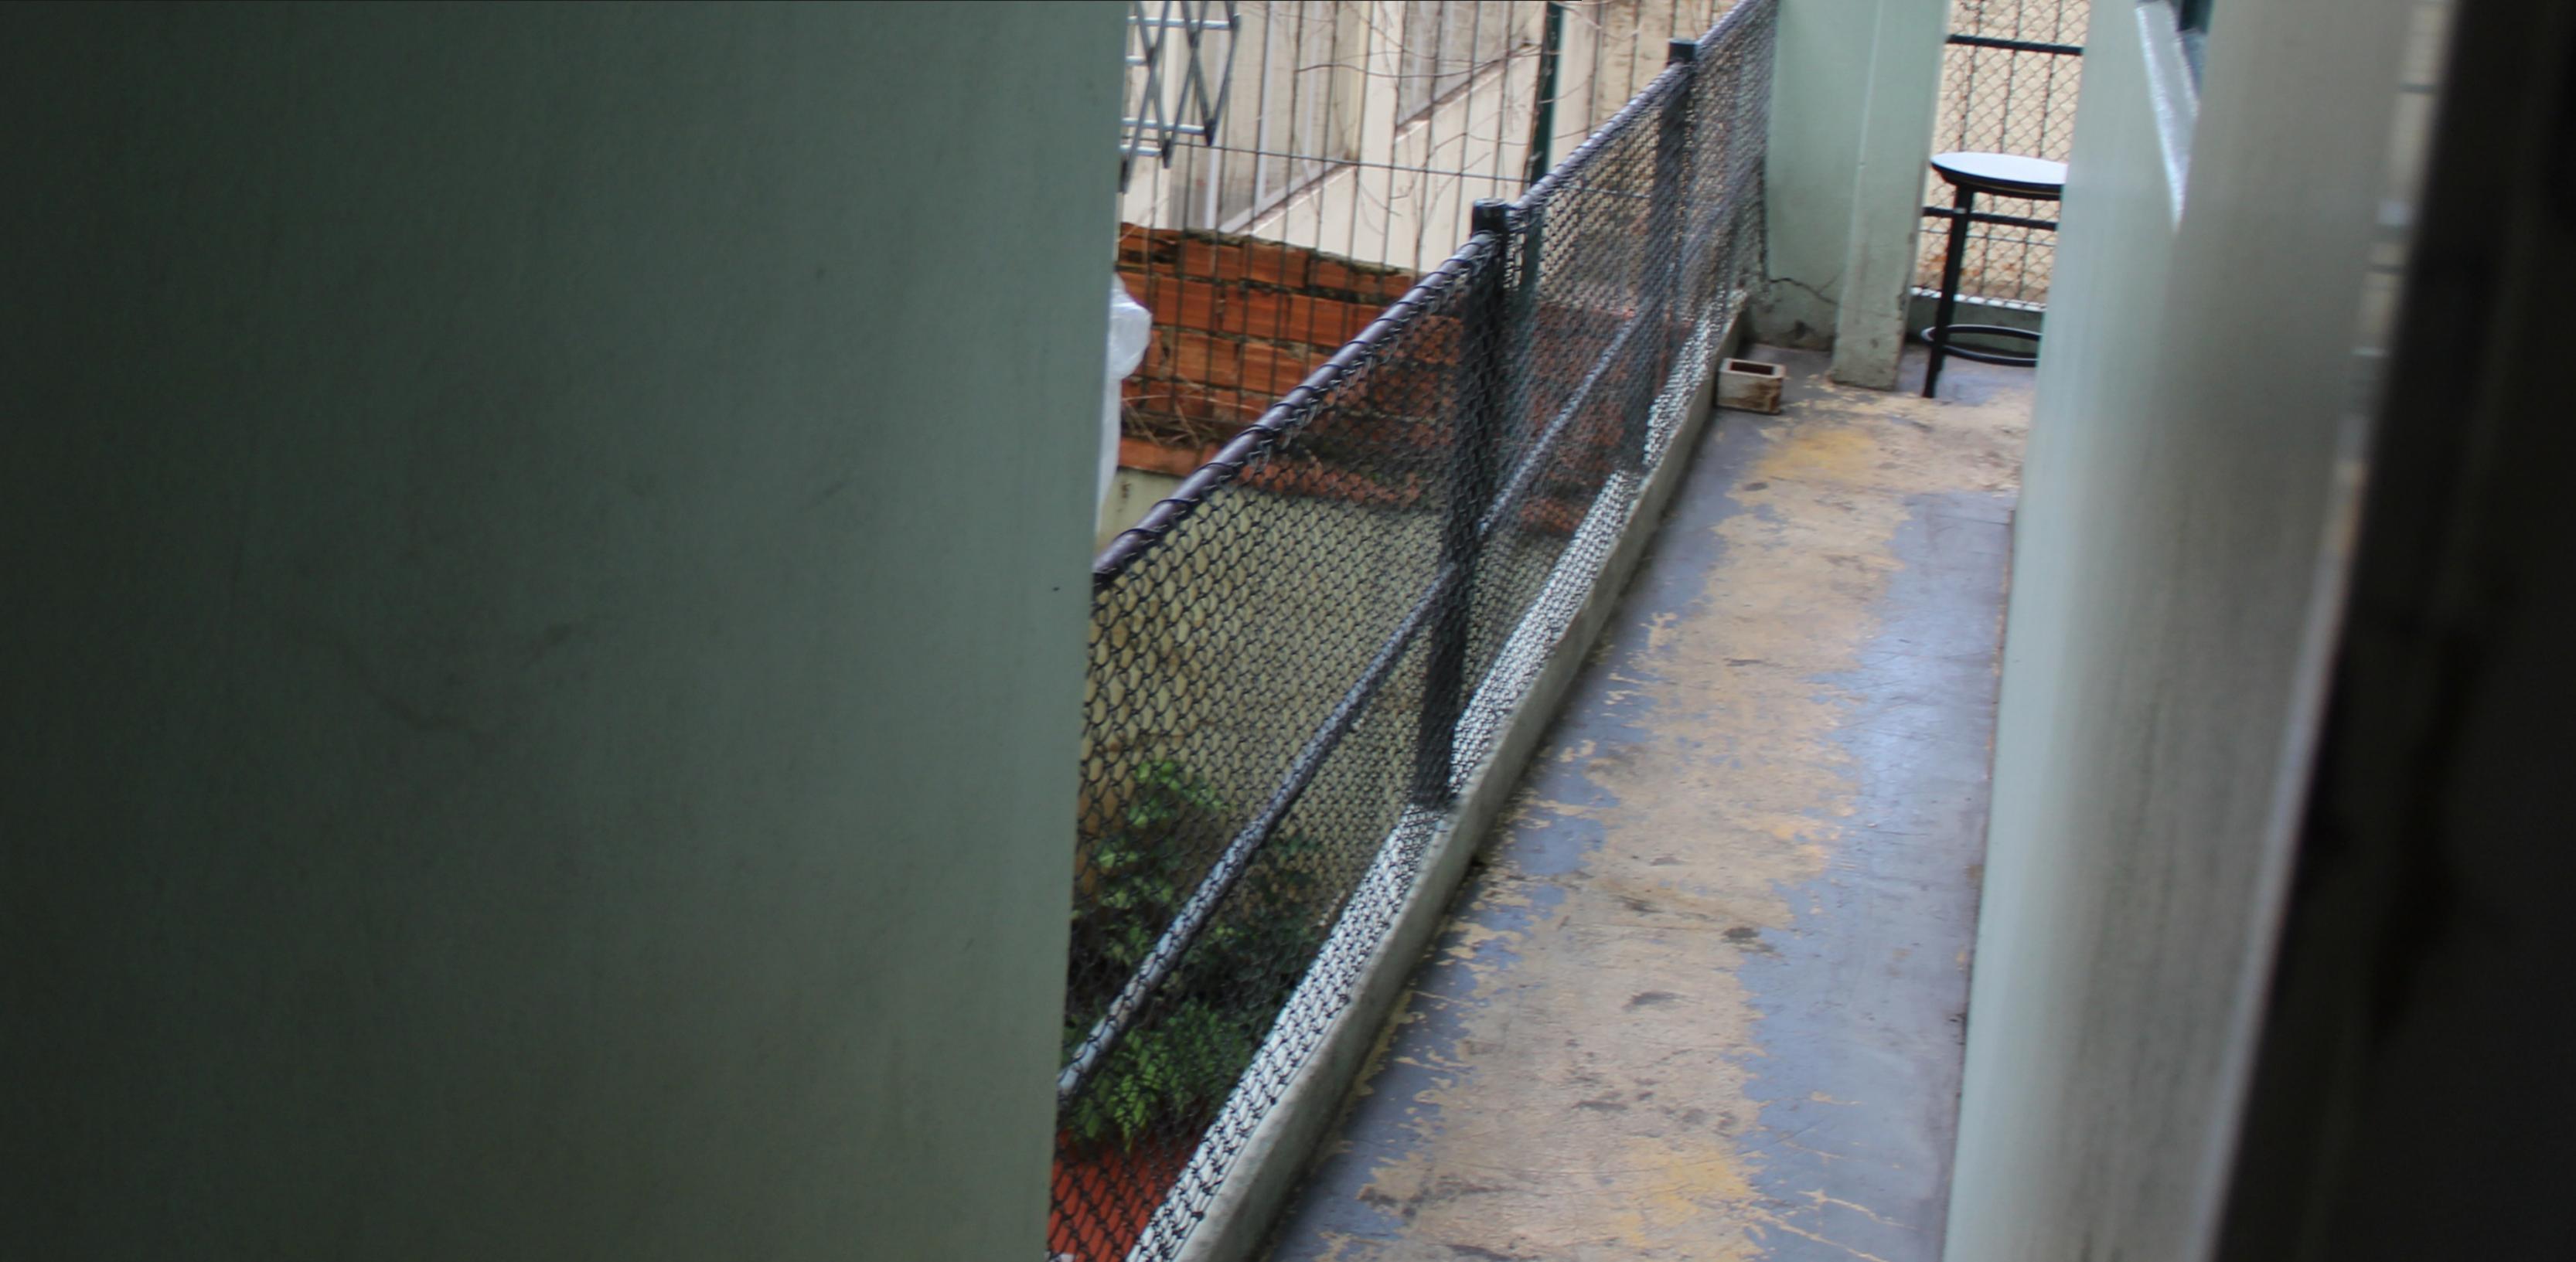
SACADA SEM REDE DE PROTEÇÃO
