UNIDADE DE ACOLHIMENTO

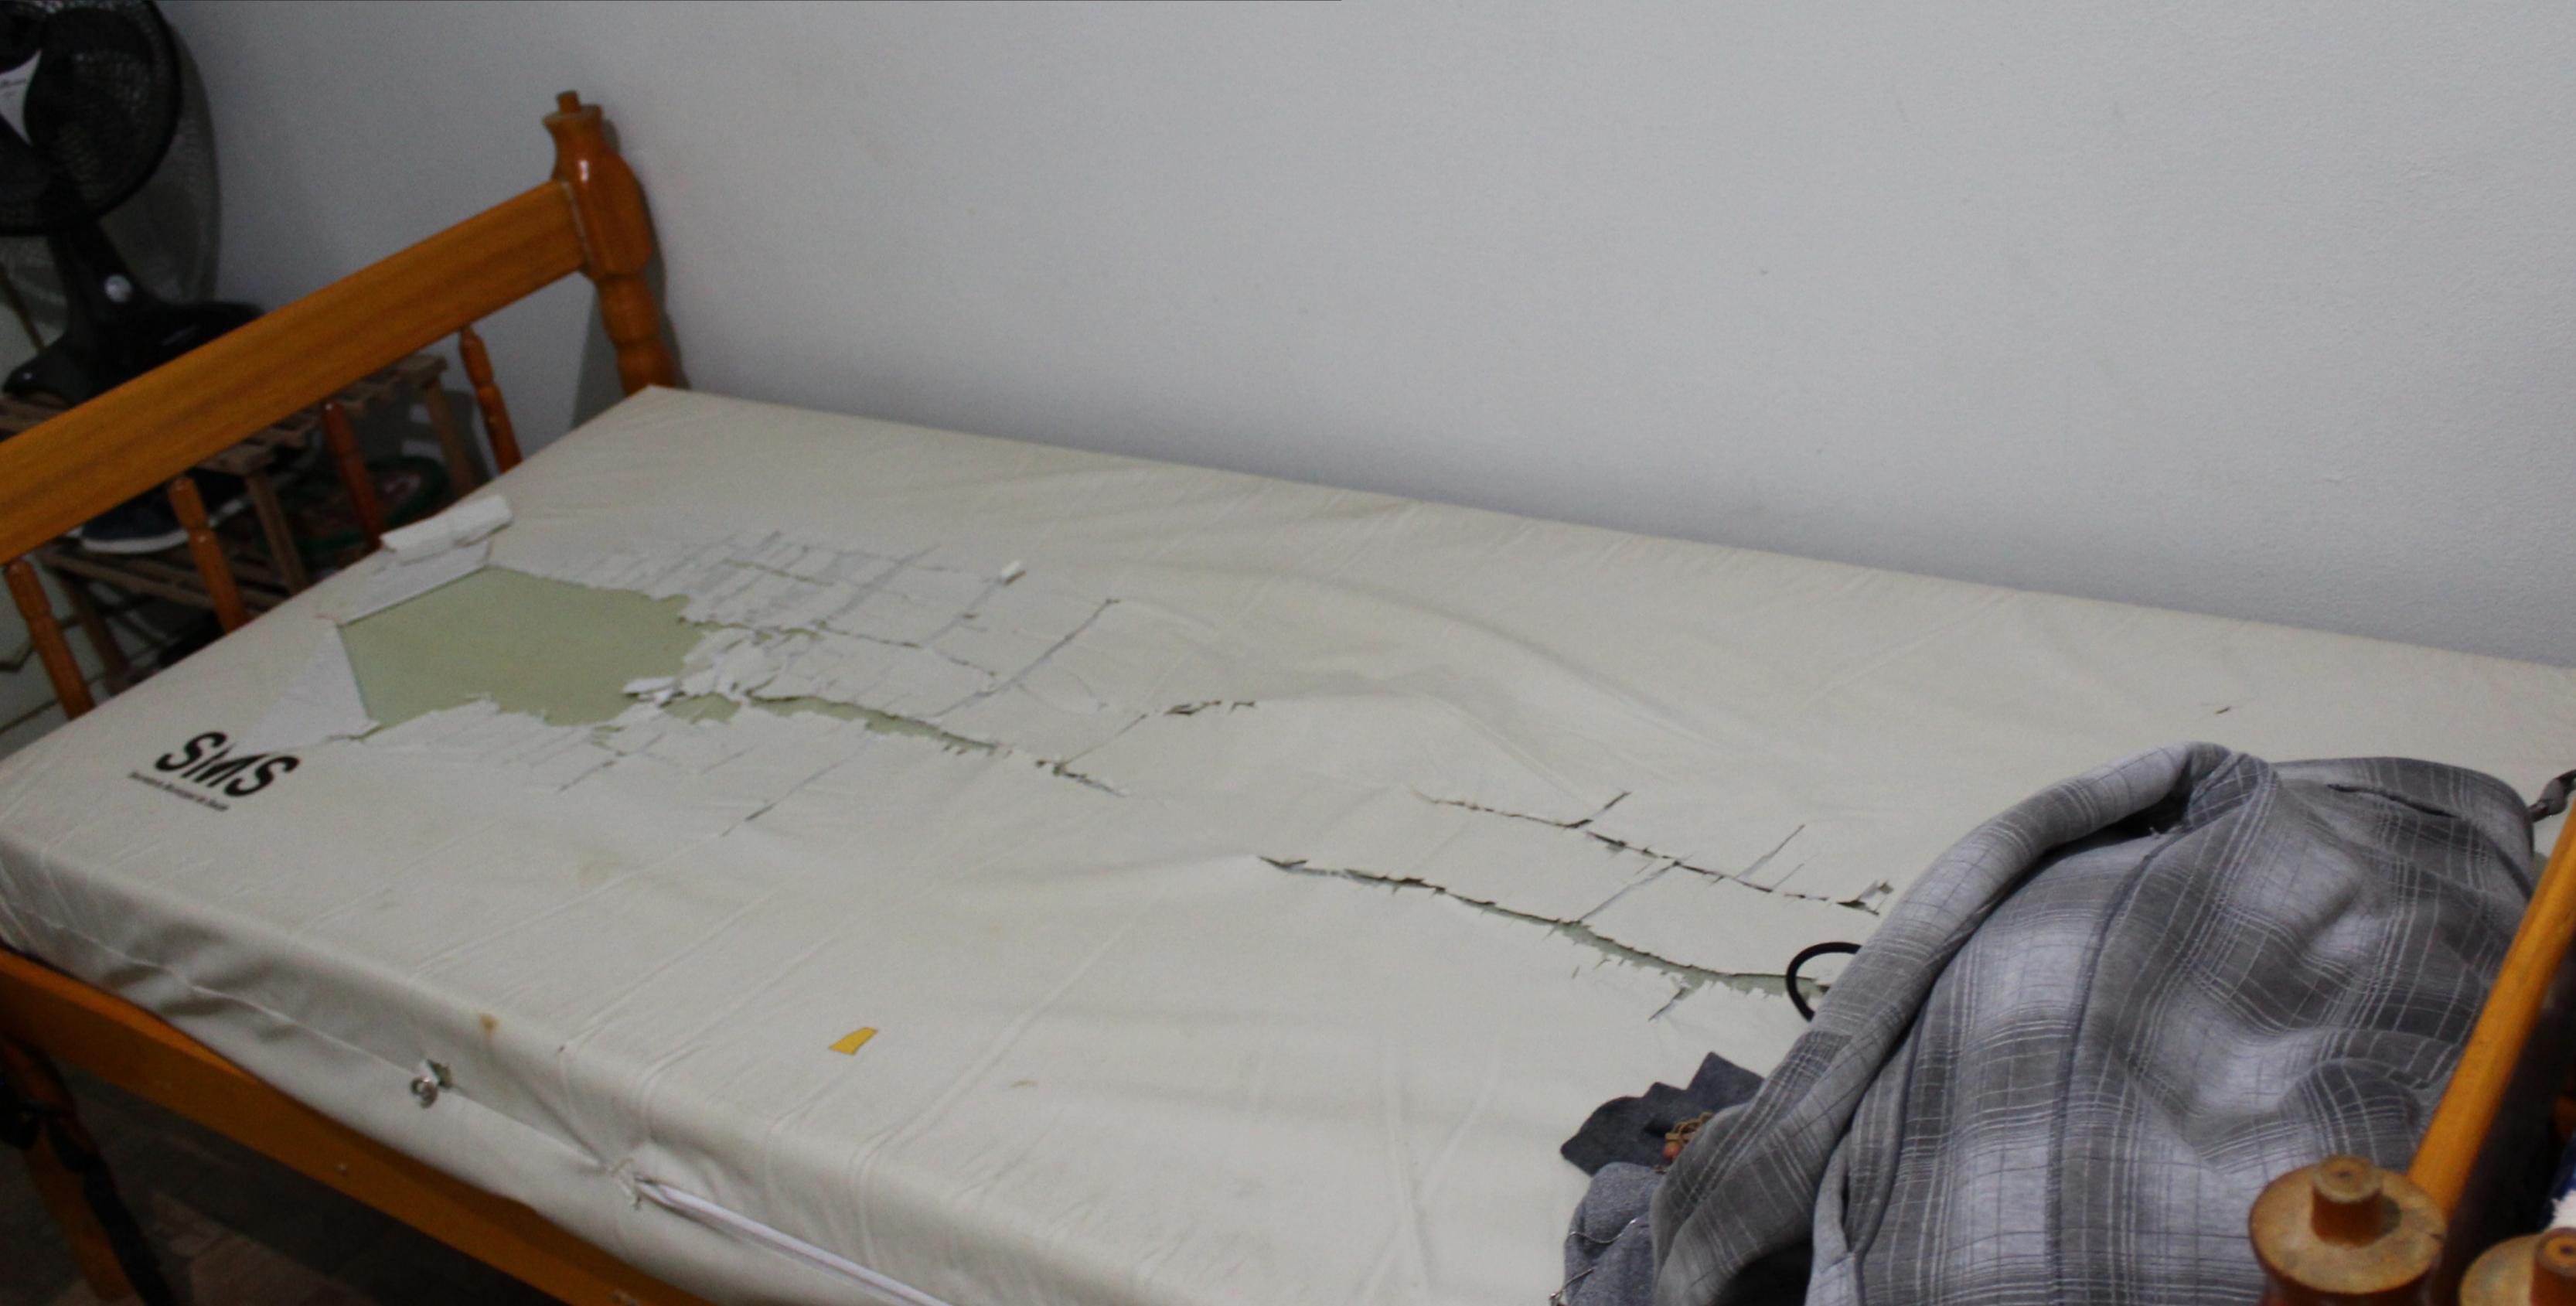
COLCHÕES DESMANCHANDO

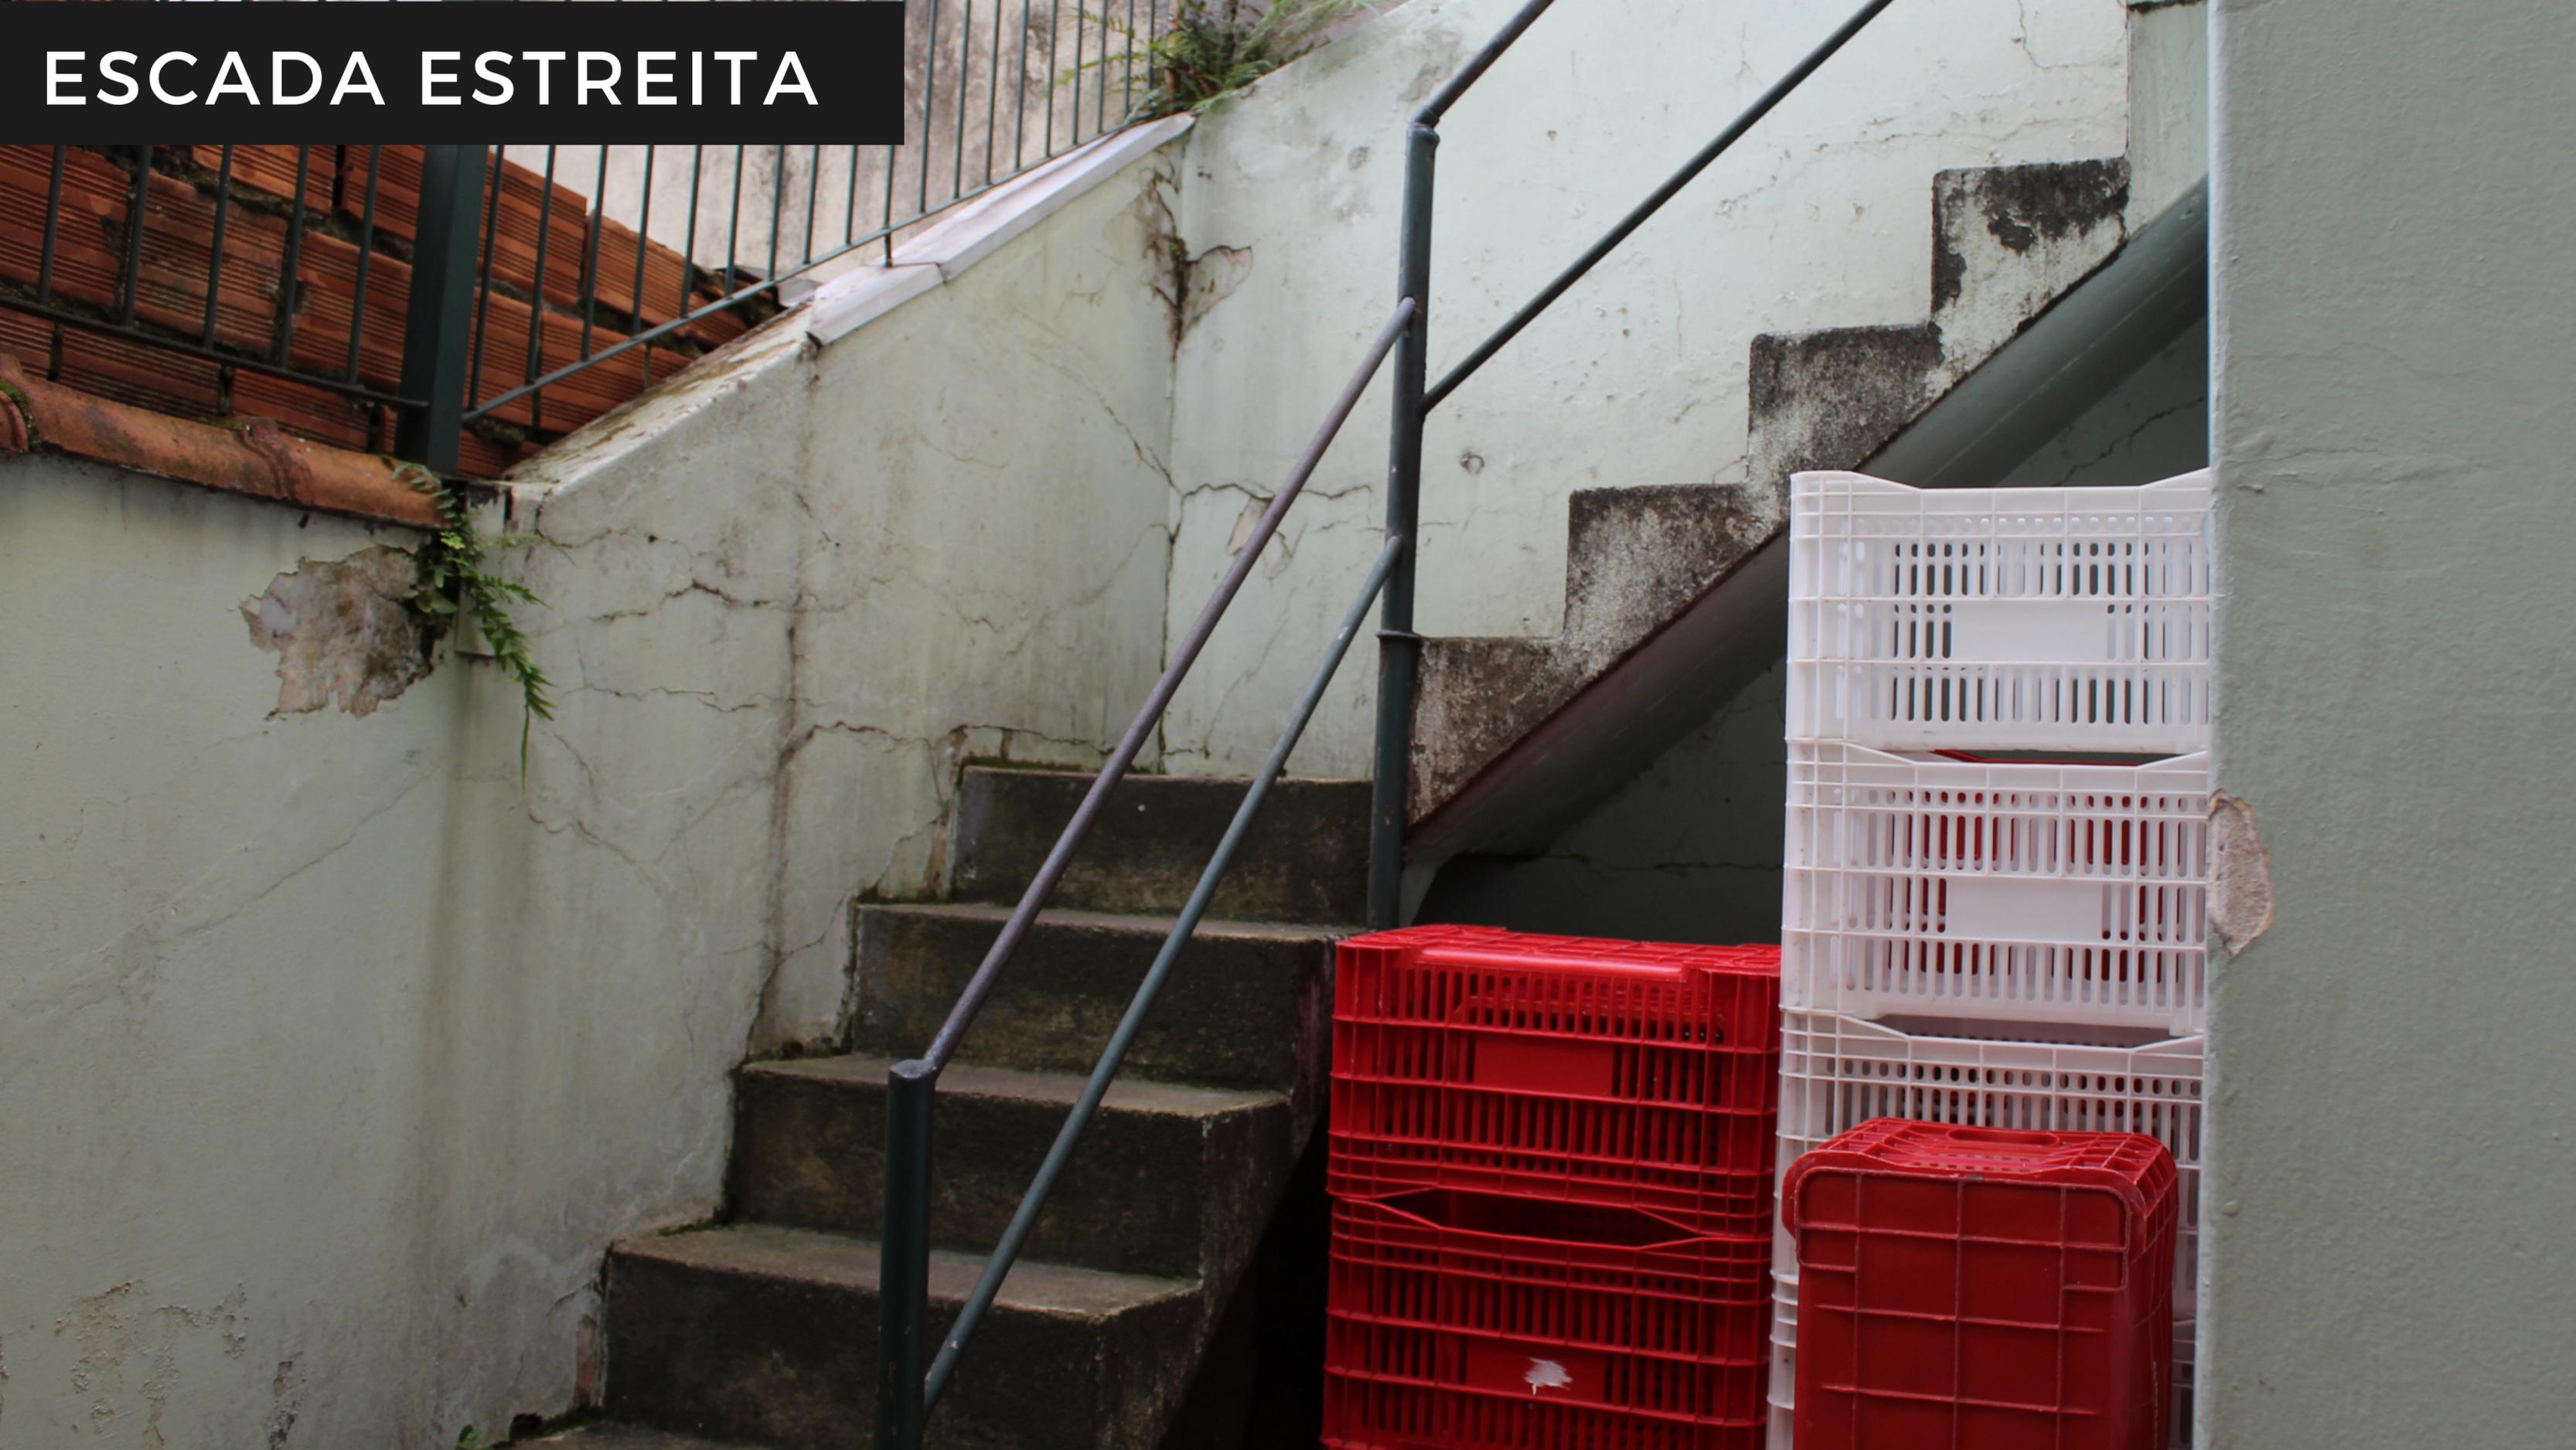
ESCADA ESTREITA
